VII. PHYSICAL PLANT INVENTORY

FACILITY INVENTORY AND INSPECTION PROGRAM

ENO RIVER STATE PARK STATUS OF FACILITIES

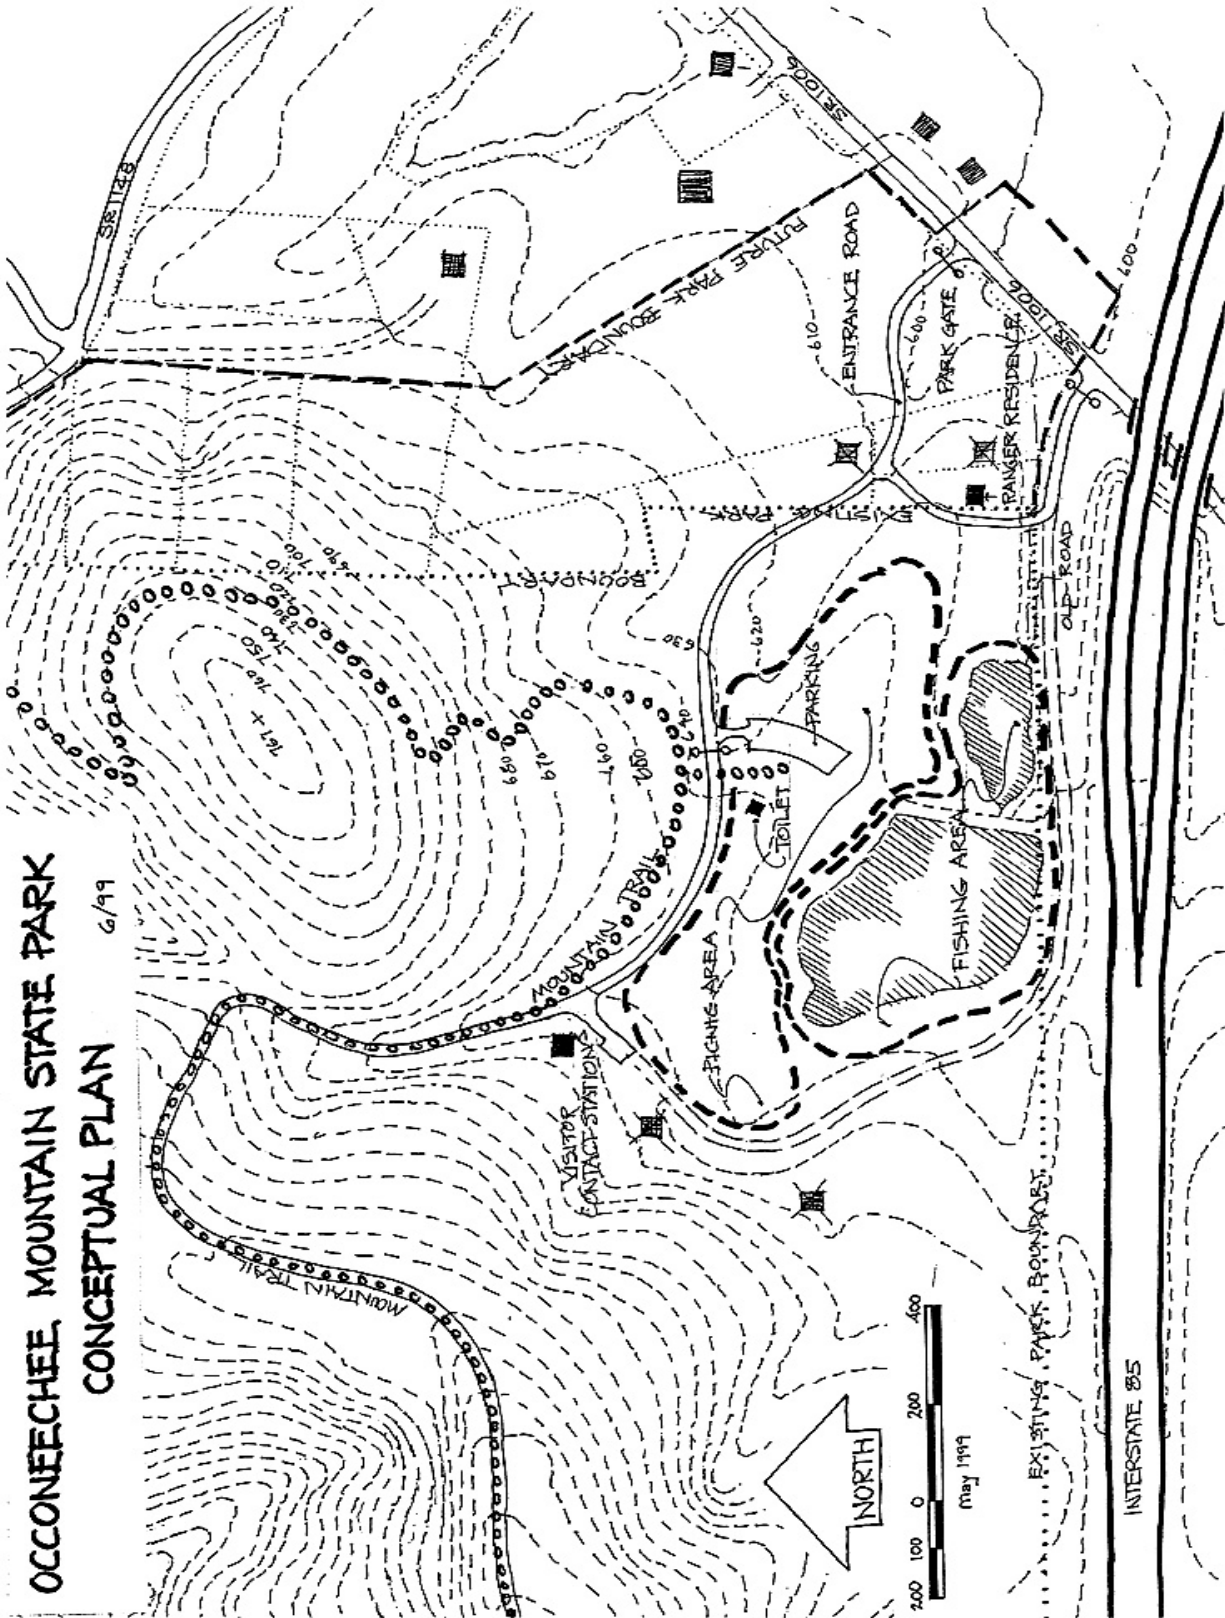
OCCONEECHEE MOUNTAIN STATE PARK CONCEPTUAL PLAN

One capital improvement project to provide for initial general development at Occoneechee Mountain is proposed. The project will include development of an access road, handicapped access to the visitor contact station and pier, road improvements to the maintenance area, contact station renovation, entrance gate, equipment storage shed, fishing pier at the pond, relocation of the vault toilet, parking lot, ranger residence, well house and chlorination equipment, water distribution lines, area light at the gate and underground electric service. A conceptual plan of the proposed initial development follows.
