Goose Creek State Park General Management Plan

*North Carolina Department of
Natural and Cultural Resources
Division of Parks and Recreation*

*Coastal Region
May 2023*

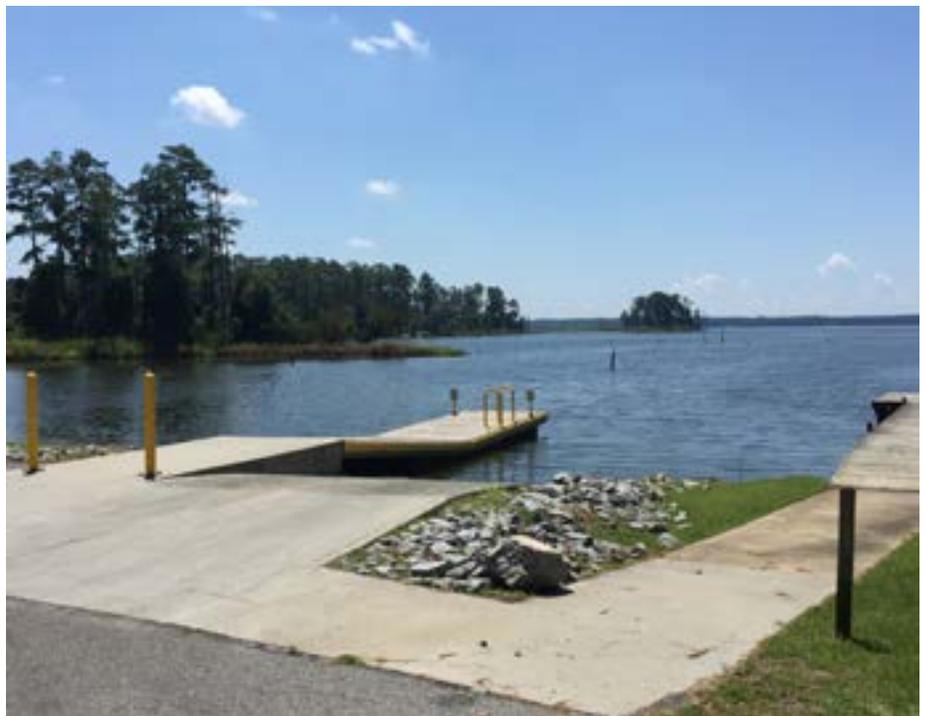
The footings of the boat launch at Dinah's Landing needs a structural assessment performed due to excessive use, current and age.

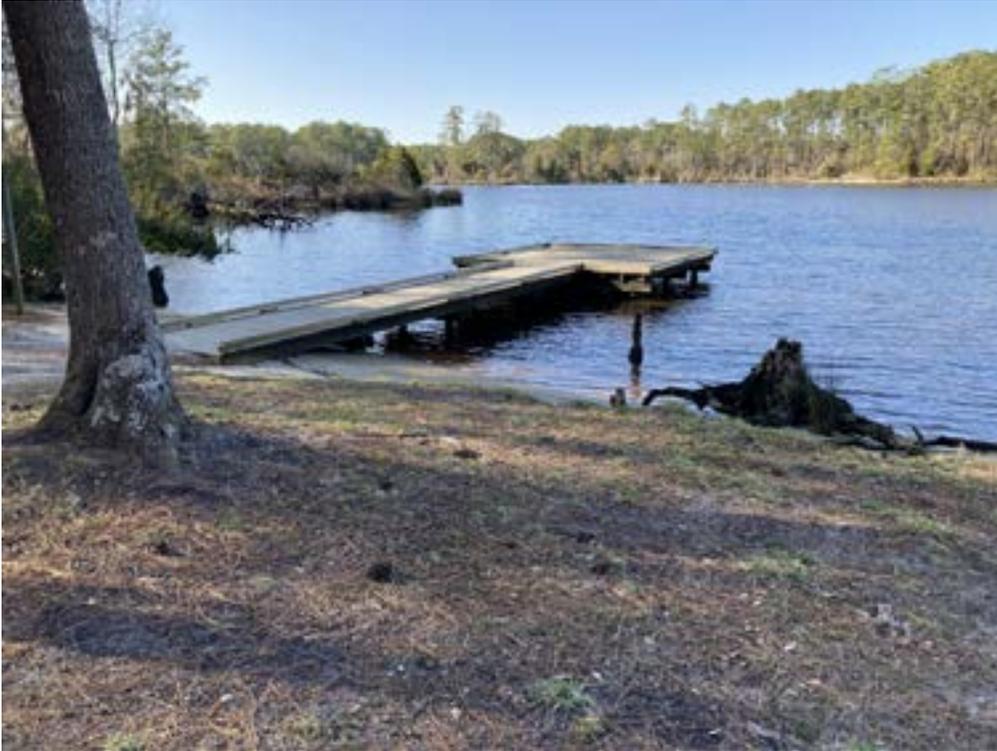
Non motorized boat launch at primitive campground provides an amenity for campers

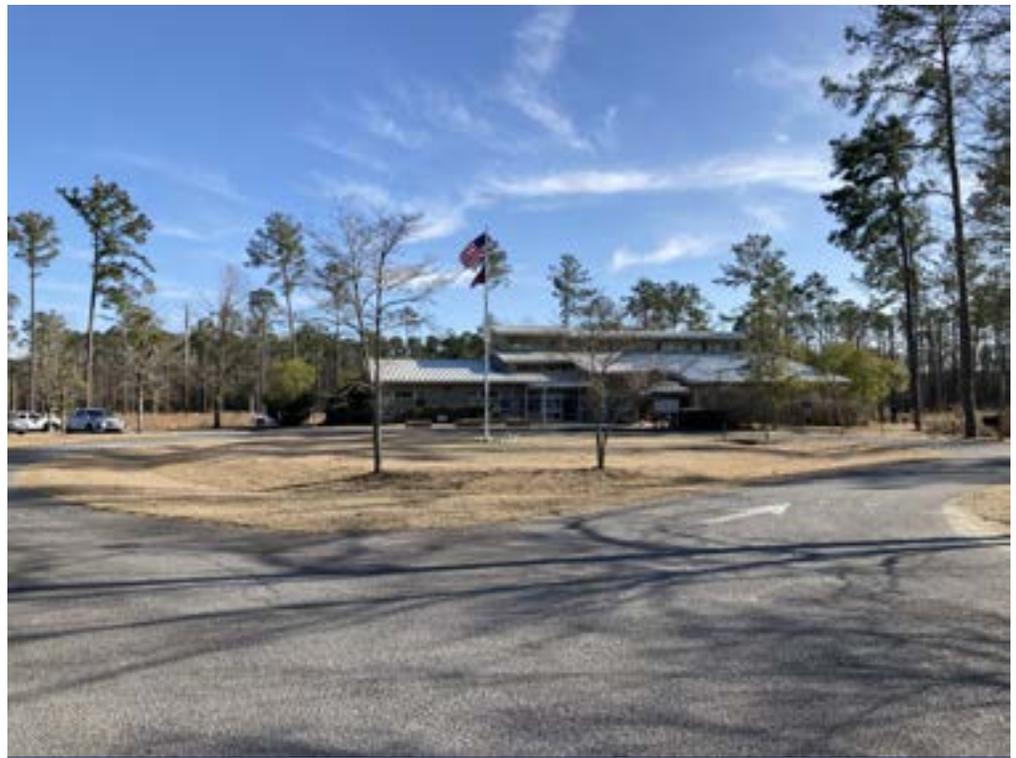
Environmental Education Center was built in 2000 and needs updated base on use, exposure to wind, and age

The Environmental Education Center (EEC), was constructed in 2000, and needs routine maintenance and upgrades. The project lifespan is 40 years. Prior to design and construction, park staff will determine the feasibility of renovation versus new construction methods.

- Remove and Replace all exterior windows;
- Remove and replace all exterior trim and siding with composite siding;
- Paint exterior and interior EEC building;
- Replace water damaged wallpaper or paint;
- Replace carpet (10,700 sq. ft.);
- Replace damaged ceiling tiles in auditorium;
- Remediation of mold in auditorium caused by water intrusion;
- Install insulation in ceiling in auditorium;
- Upgrade fluorescent lighting to LED throughout the building; and
- Replace all exterior door hardware and locks.

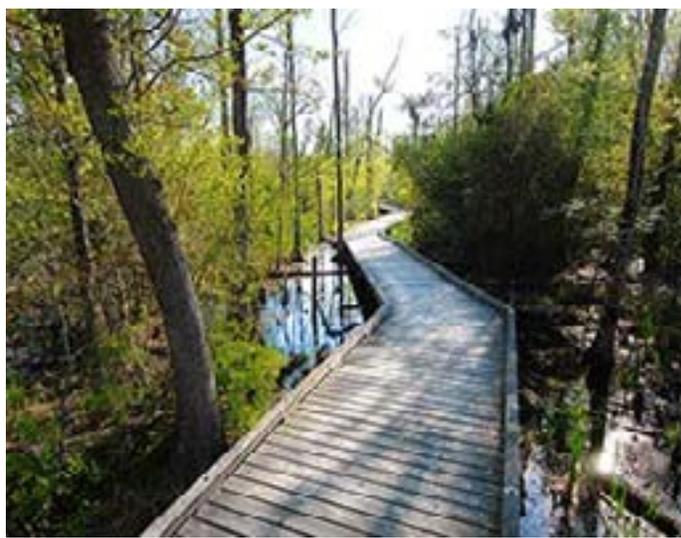
Palmetto Boardwalk Trail is the signature or interpretive trail in Goose Creek State Park

Palmetto Boardwalk Trail: This 0.50 mile easy one-way hiking trail starts from the Environmental Education Center to the junction of Tar Kiln Trail. A majority of the trail is on boardwalk.

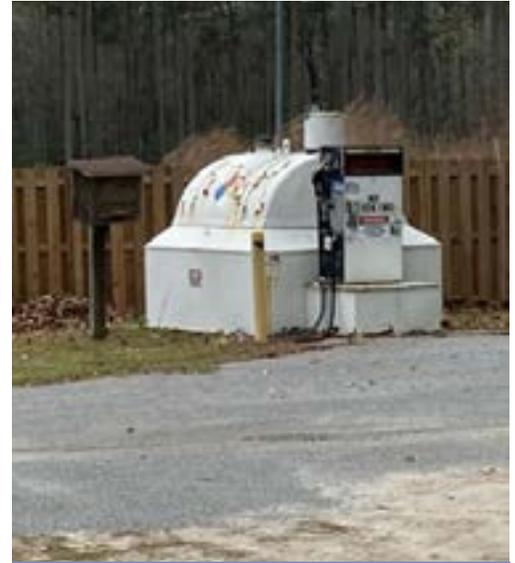
Existing fuel tanks are over 50 years old and needs to be replaced.

Separate diesel and unleaded fuels tank permitting will be reviewed and approved thru CAMA thru NCDEQ.

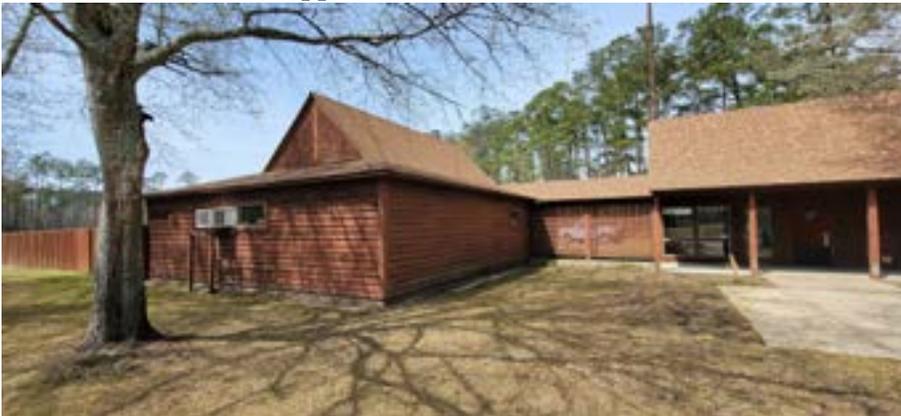
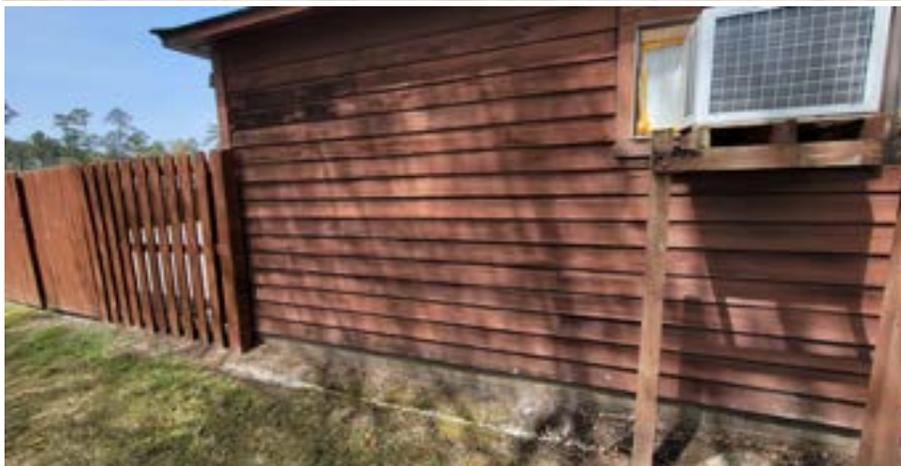
The maintenance building was constructed in 1982. The siding needs to be replaced with sustainable building products.

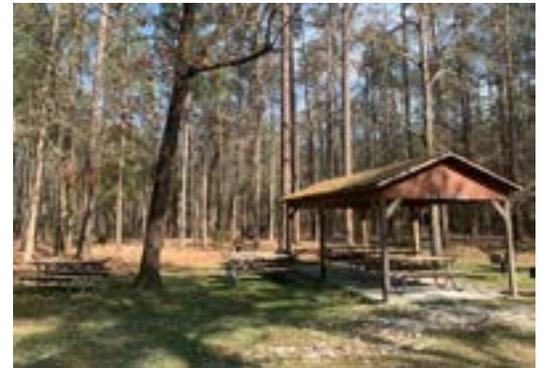
Several picnic shelters need roof replaced due to wind damage and age.

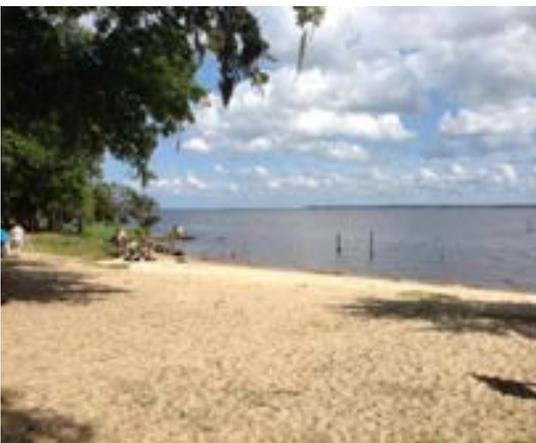
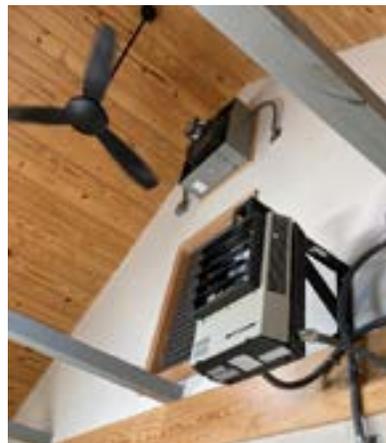
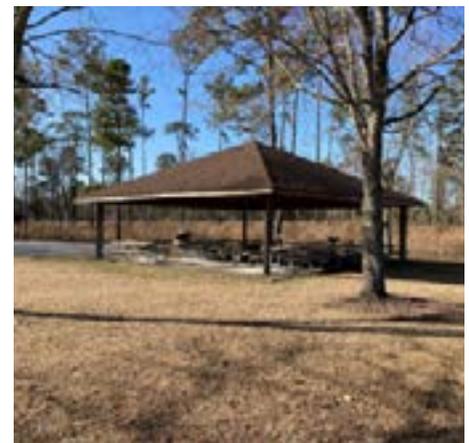
Swim beach needs a wash down station, install a ventilation system to reduce condensation in the family campground shower house, and replace roof at day use shelters.

- Install air conditioning system with dehumidifier unit, or air duct system to campground shower house due to the abundance of moisture concerns;
- Install a wash down station at Swim beach with an automatic shut off value system;
- Install additional wash down stations near the swim beach shelter;
- Inspect footings at Dinah pier and dock at primitive campground due to excessive salt and wind;
- Roof replacement at two (2) swim beach shelter;
- Roof replacement at Flicker Field Shelter, and
- Install booster pump system to municipal waterline to increase water pressure levels to the Family Campground.

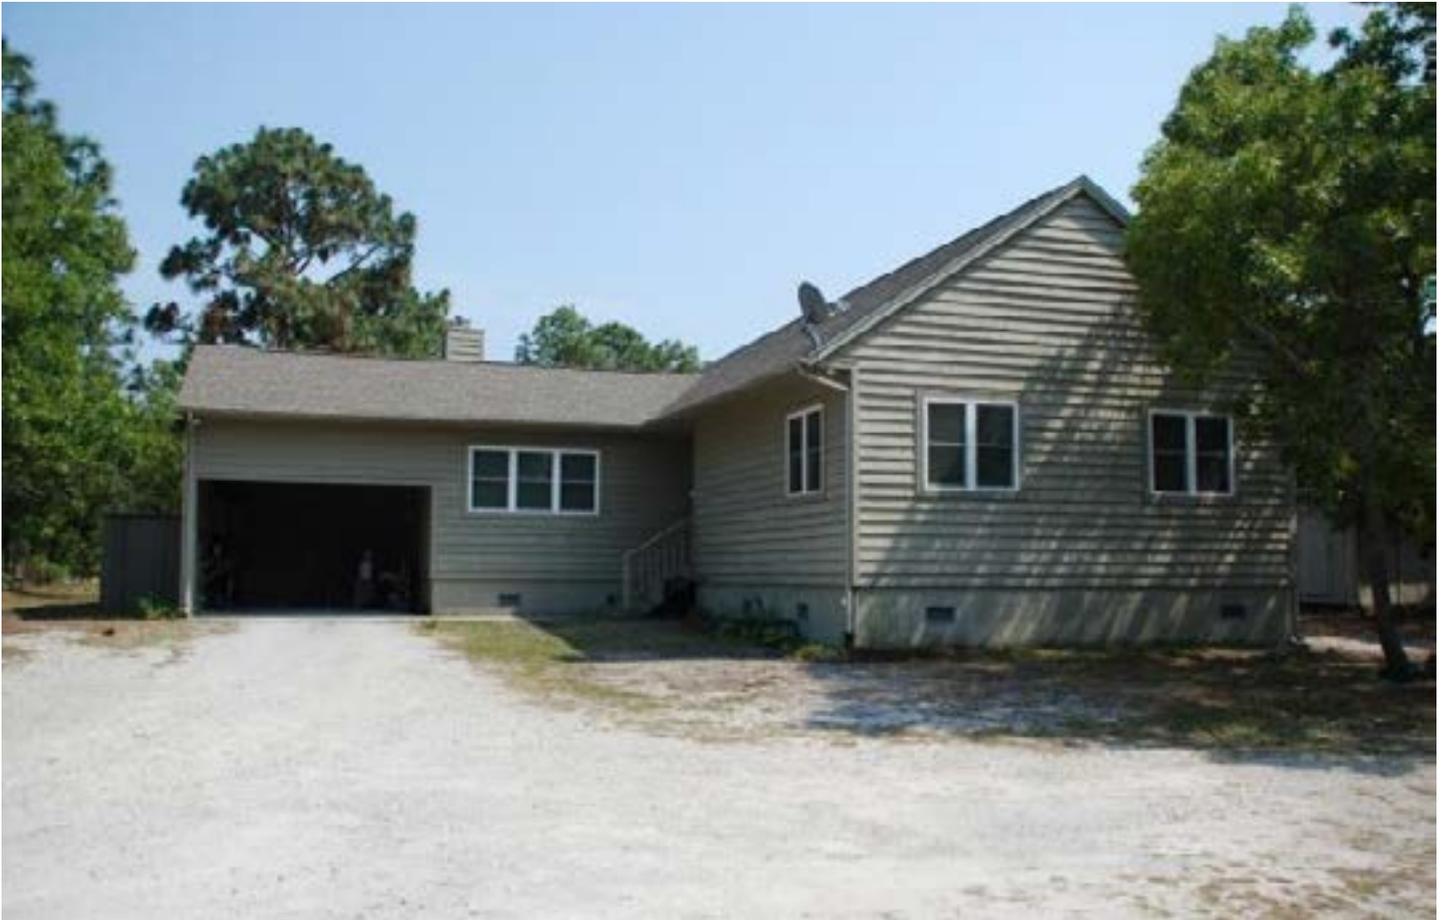
A coastal style park residence needs to be stationed in the western section of the Goose Creek State Park. The minimum 2,000 square feet structure will include 2 or 3 bedrooms and a garage.

In order to provide adequate response time to emergencies and provide customer service at the family campground, park staff needs to be stationed in the western section of the park. This will help retain staff within the Division. Prior to construction, the consultant will evaluate the feasibility and cost analysis of purchasing and installation of a prefabricated structure. The 2,000 Sq. Ft. Residence will include 2 or 3 bedrooms along with a garage or carport.

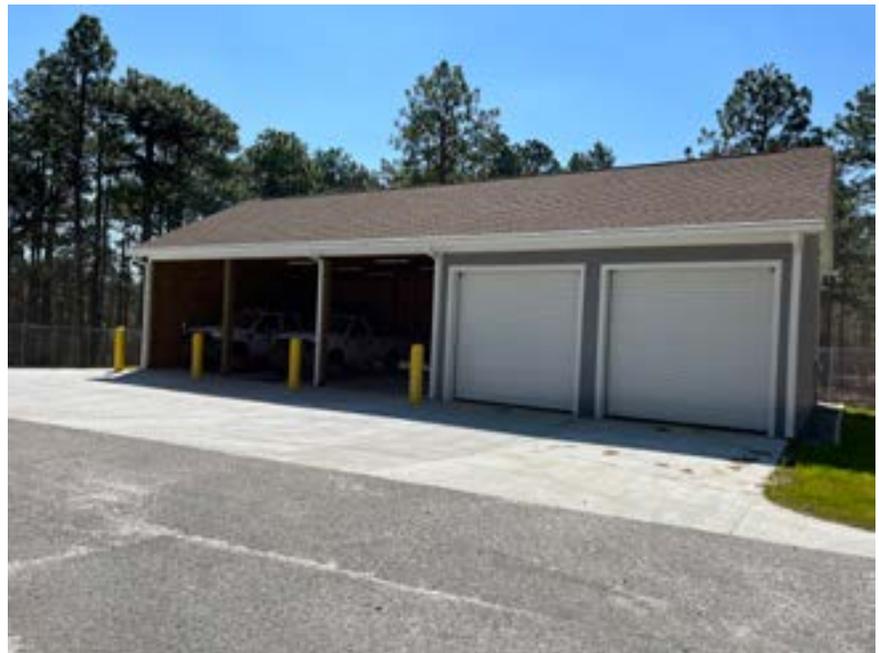
The storage shed building at Weymouth Woods Sandhills Nature Preserve provides secured space for vehicles and equipment.

- Mobilization, site work;
- Proposed equipment storage building -5 bay;
- Lumber storage area;
- Concrete pad;
- Electrical extension from existing maintenance building-(1,000 Lin Ft.);
- Water source - municipal water line;
- Proposed 6' high Chain link fence (min. 1,000 Lin Ft.);

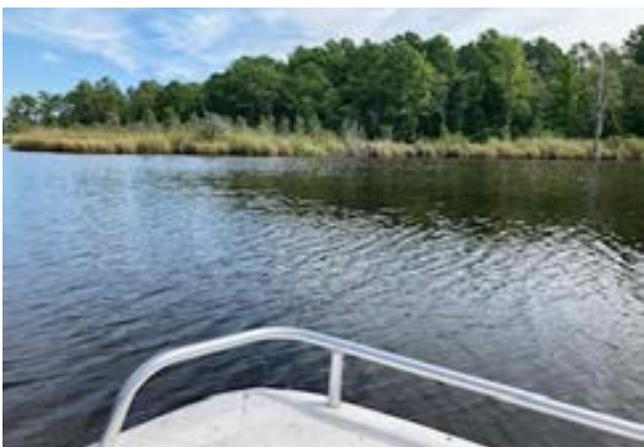
Approximate location of the proposed water access along Pamlico River

- Floating dock system for non-motorized vessels;
- Trail connection.

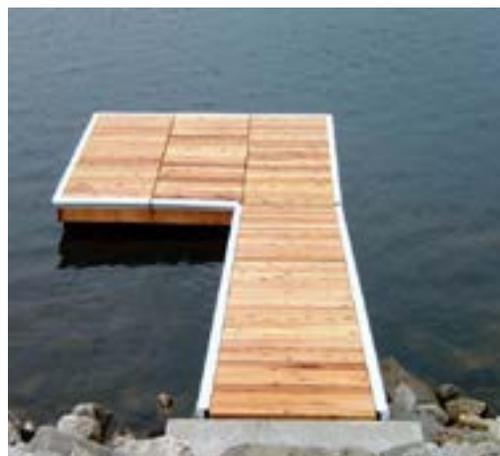
Example of a Proposed floating dock system

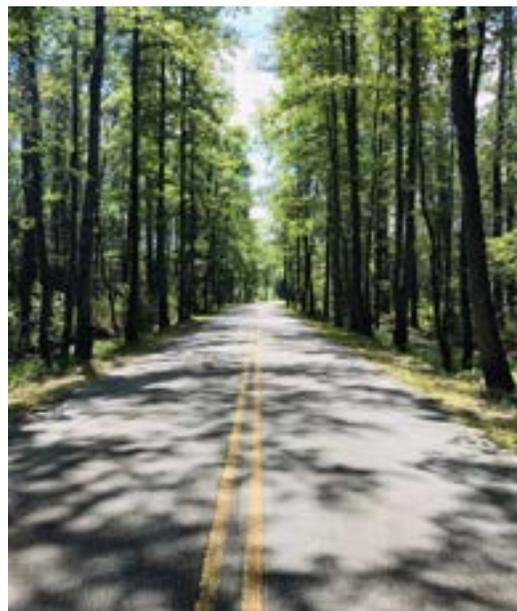
The Goose Creek Park Road needs a 1" asphalt overlay in order to accommodate for heavy duty vehicles.

During 2022, the park capacity increased by 74 %. A 1" overlay, heavy duty is needed for park visitors, staff, maintenance and prescribed burning equipment. Park staff will work with NCDOT to coordinate and prioritize projects. Some areas are in low lying, degrading and located in wet areas.

- Paving the maintenance entrance road (325 linear feet);
- 1" asphalt overlay on park road (14,400 linear feet);
- Dinah's Landing (700 linear Feet); and
- 1" Asphalt overlay on Multi-Use Trail near Swim Beach access (450 Linear Feet).

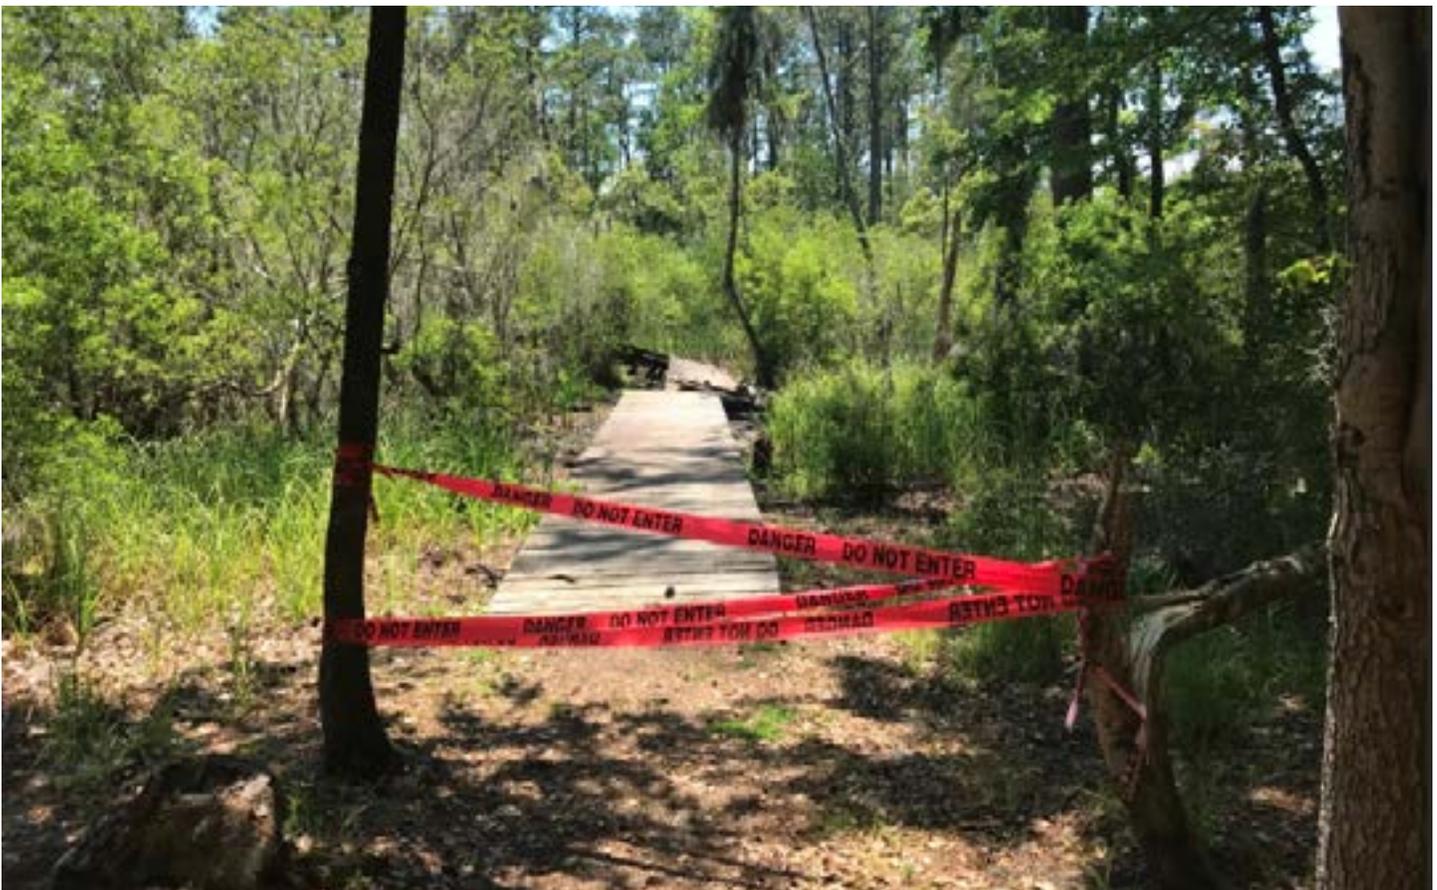
Sections of the Flatty Creek Trail boardwalk needs to be removed and replaced due to structural damage from several hurricanes

Prior to design, the cost benefit analysis of timber construction compared to precast concrete boardwalk (5,000 lbs.) will be determined. The finished floor elevation will be determined based on the flood elevation and projected sea level rise.

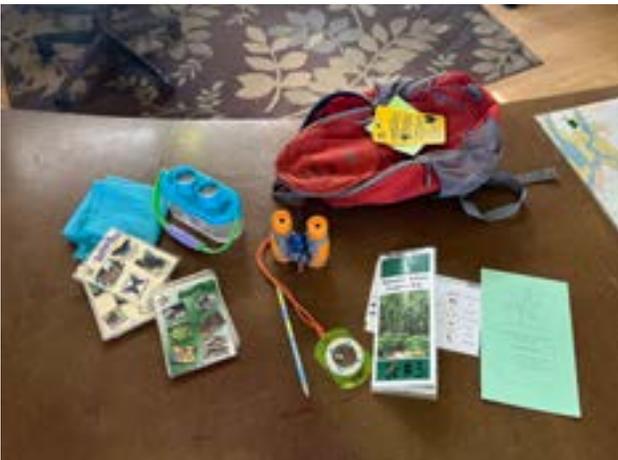
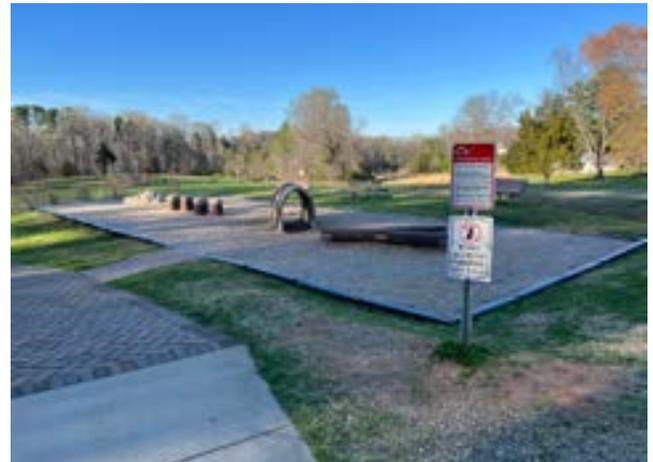
Example of nature based play area at Ann Wilkerson, M.D. Nature Preserve managed by City of Raleigh

- Lily pads;
- Spin playground structure;
- Log type tunnel;
- 9” deep; Engineered wood fiber playground mulch; and
- Site improvements, such as a interpretive signs, picnic table and a park bench.

The equipment should be similar or equal to Ann Wilkerson, M.D. Nature Preserve, managed by City of Raleigh, or Hemlock Bluffs Nature Preserve in Cary, North Carolina. The fall-zone shall be less than 24” for liability, inspection, and long range maintenance purposes.

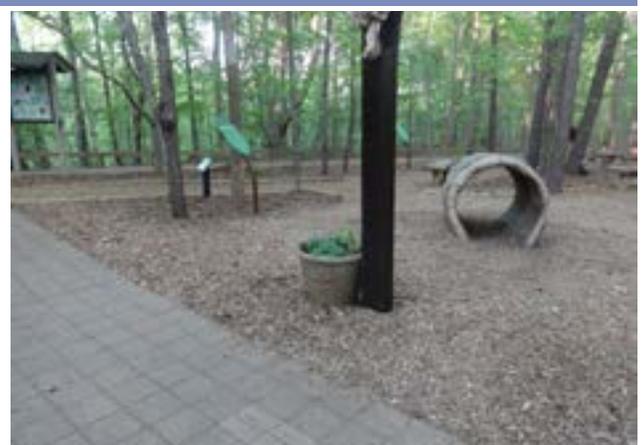
Example of nature based play area at Hemlock Bluffs Nature Preserve in Cary, North Carolina, includes a lily pad type structures and log type tunnel.

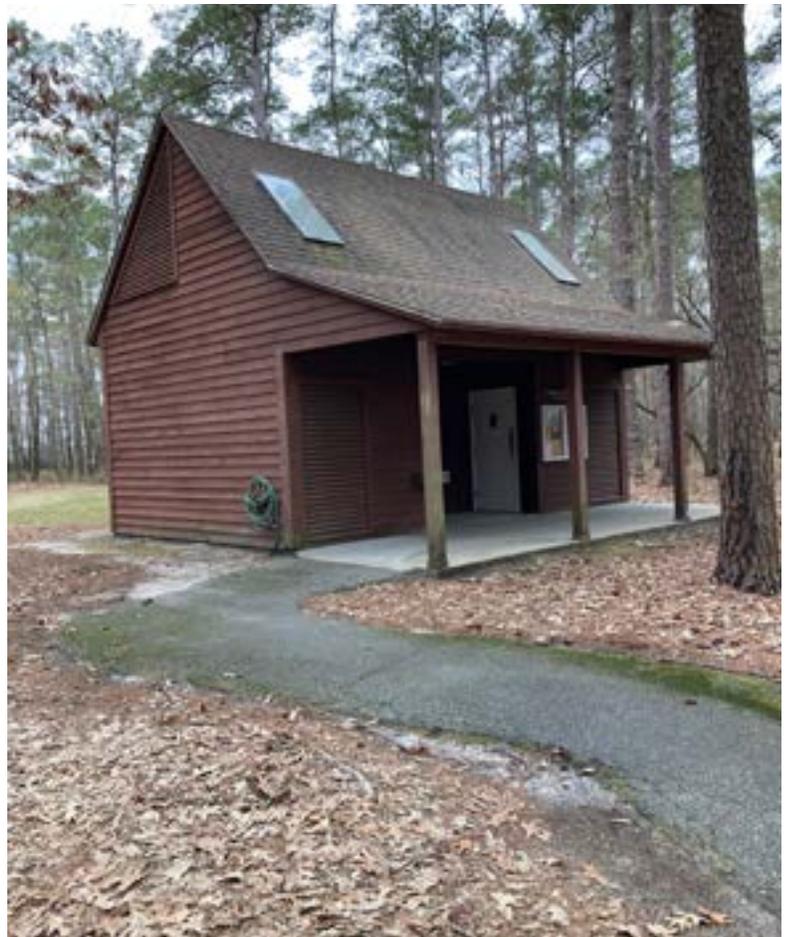
The existing restroom building is past the expected lifespan and needs to be replaced

- Site work and fill dirt;
- Demolish restroom;
- Proposed restroom(minimum 1,200 Square feet); raised minimum 18 inches above finished grade;
- Fill material;
- Infrastructure, hook ups and
- Electrical upgrades.

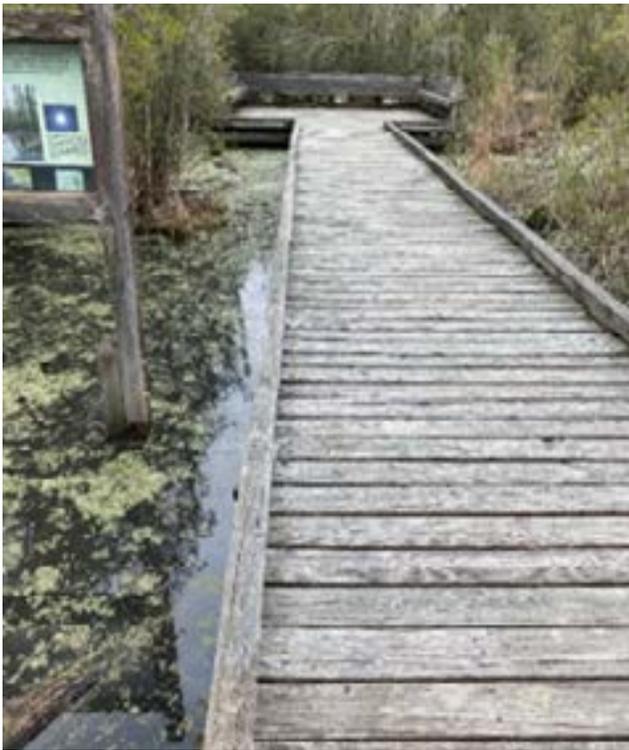
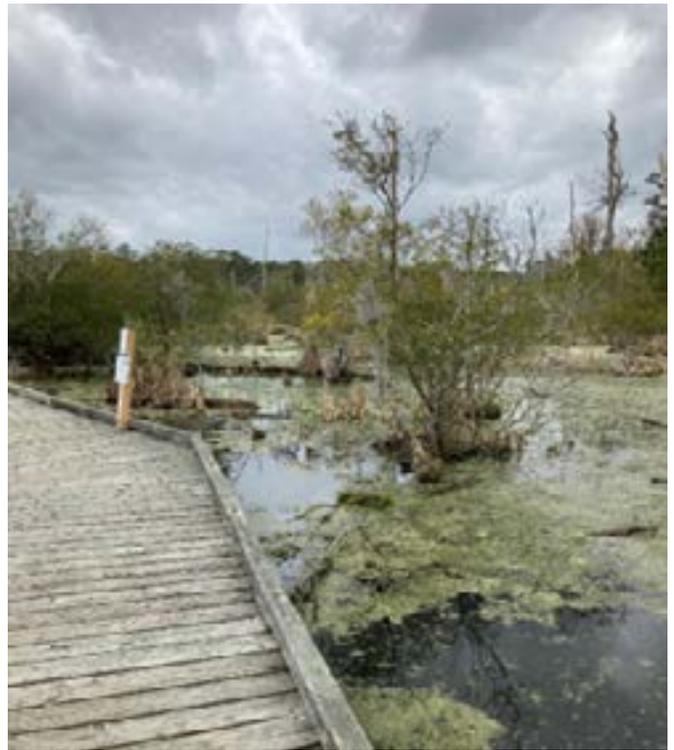
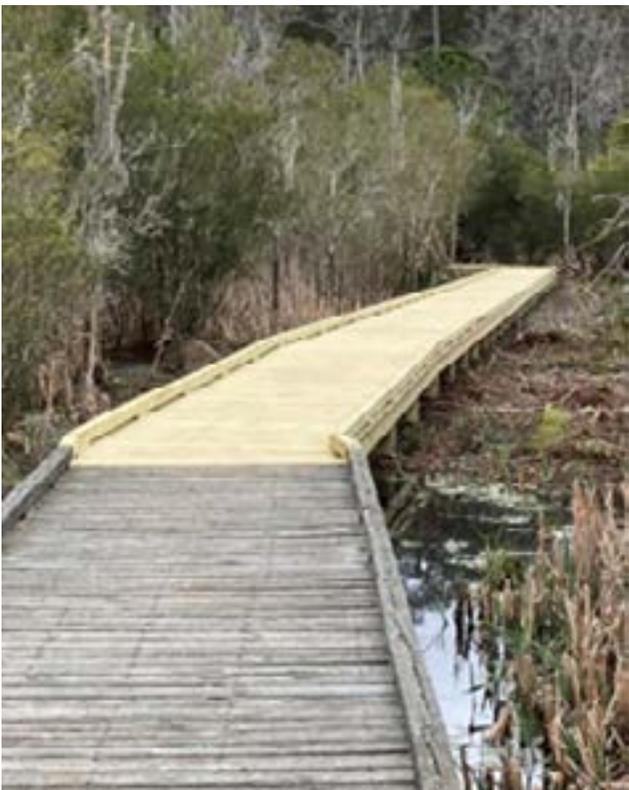
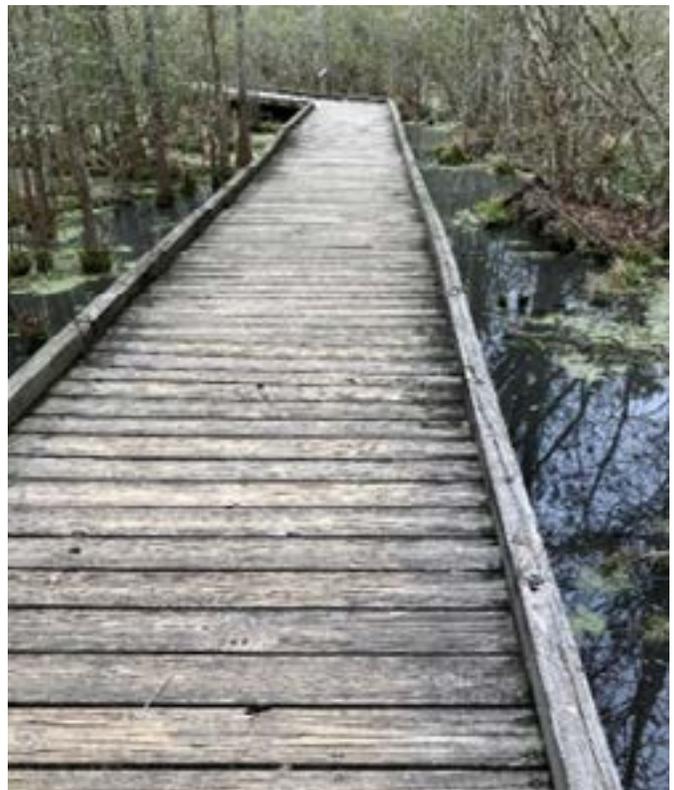
GMP PROJECT #1 - PALMETTO TRAIL BOARDWALK REPLACEMENT

The Palmetto Boardwalk, located on the backside of the Environmental Education Center, needs to be completely replaced due to hurricane damage.

Palmetto Loop was severely damaged by Hurricane Matthew and Florence in 2018.

The trail is a raised boardwalk over wetlands, marsh areas and connects to the Palmetto Loop Trail. The proposed side loop also requires 4,430 Linear Feet of boardwalk with minimum of 8 feet deep pilings. The side loop will branch off to the western section of the main trail just to the rear of the existing screened environmental education classroom and will connect back in at the proposed overlook. This will provide access and a loop system to the boardwalk to alleviate crowding when multiple groups are using the boardwalk for interpretive and educational programming. The Palmetto Trail Boardwalk demonstrates a ghost ecosystem, the intrusion of tidal water with freshwater. Park staff will coordinate with natural resources staff and permitting prior to replacement of boardwalk.

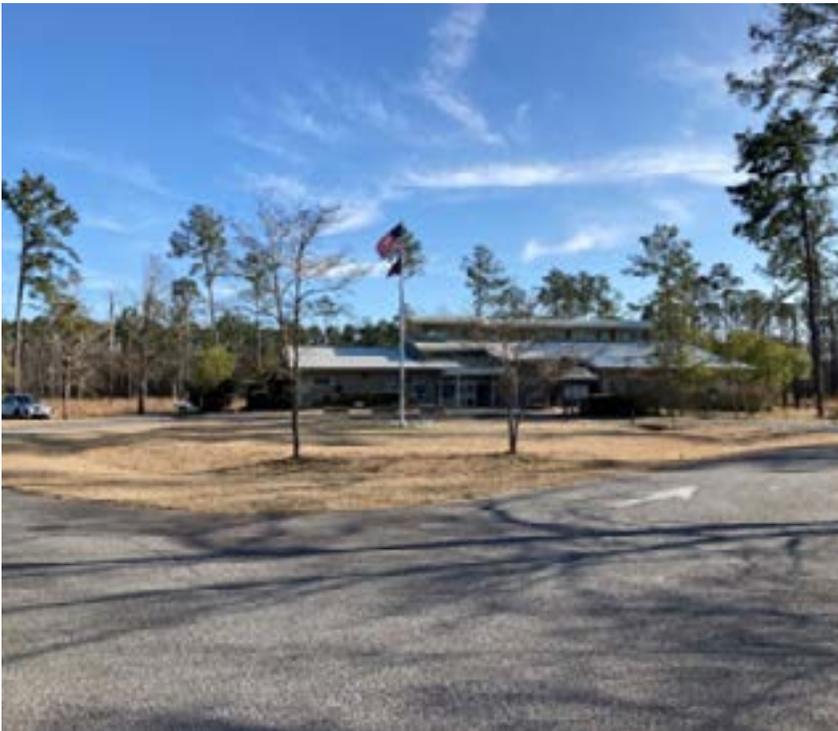
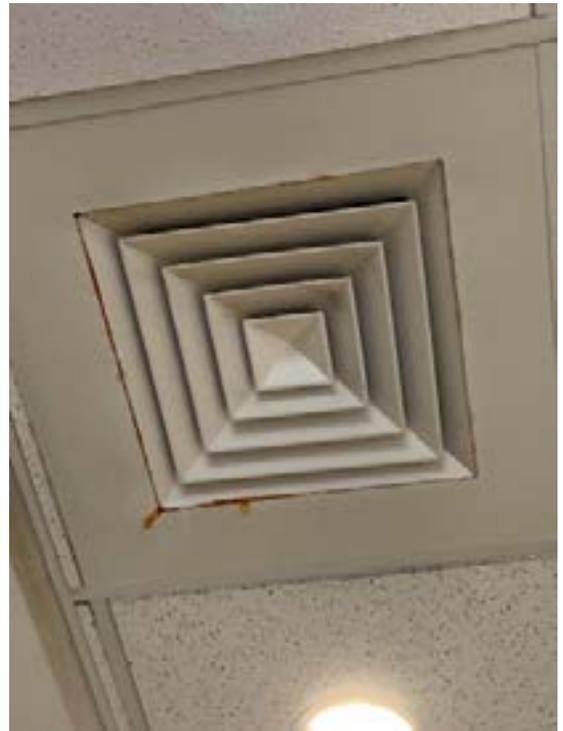
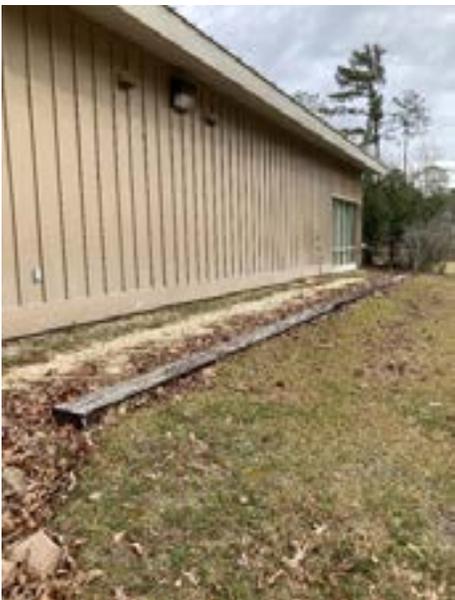
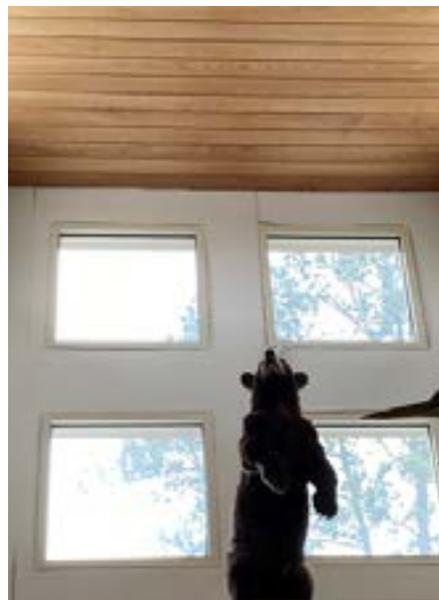
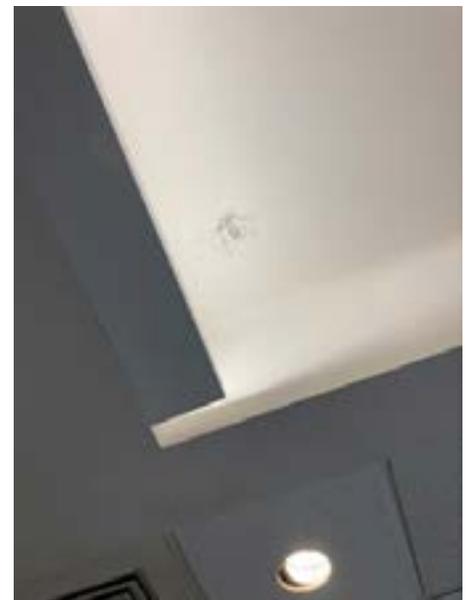
GMP PROJECT # 2: ENVIRONMENTAL EDUCATIONAL CENTER RENOVATIONS

The Environmental Educational Center needs painting, siding repairs, window replacement and clean mold in the auditorium

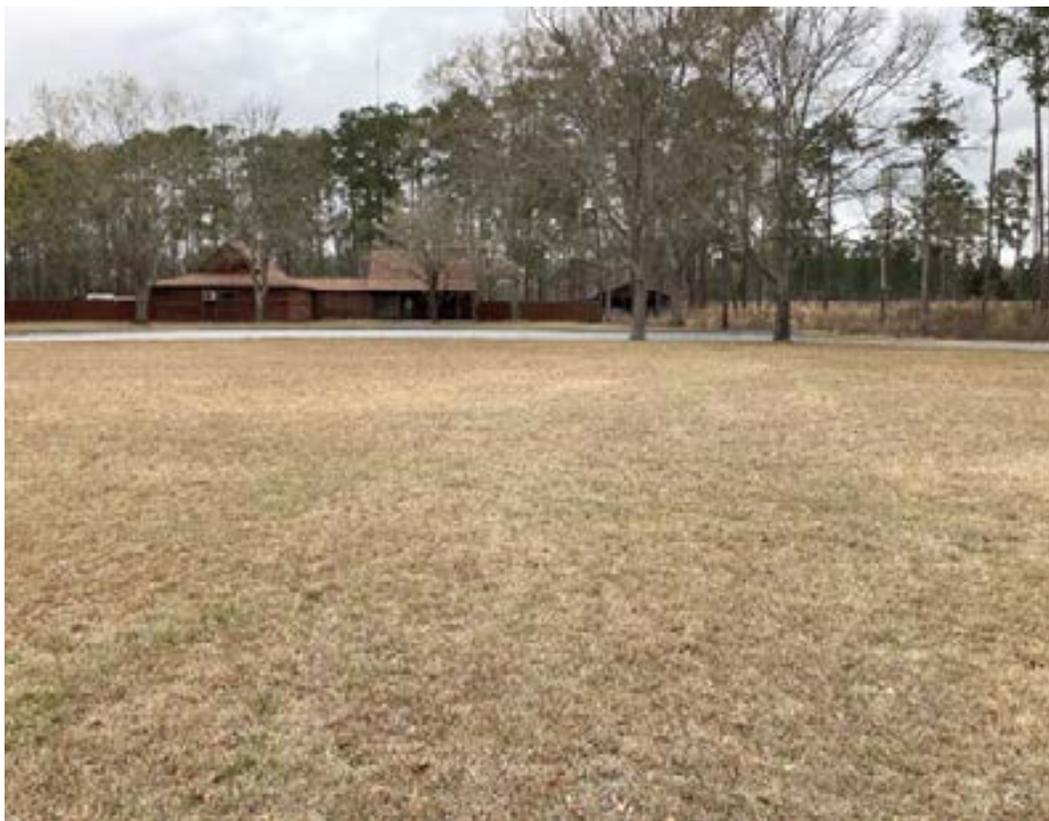
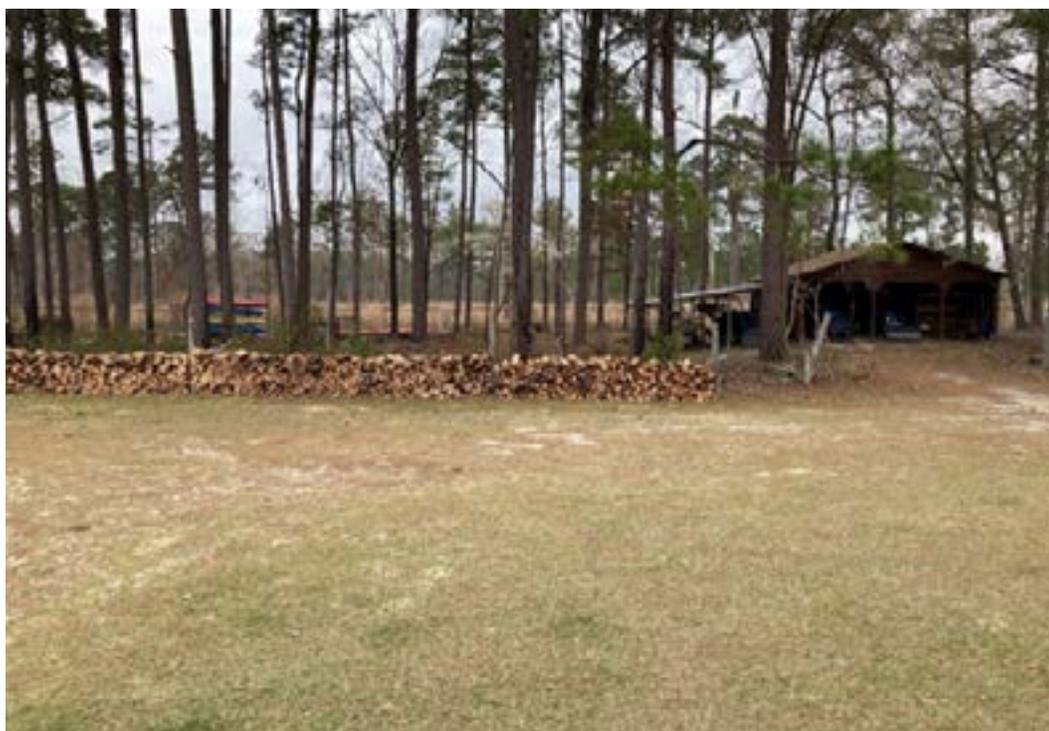
GMP PROJECT #6 - PROPOSED EQUIPMENT STORAGE BUILDING

The Proposed Equipment storage building will be located on the back side of existing maintenance building. A chain-link fence will be installed for security purposes.

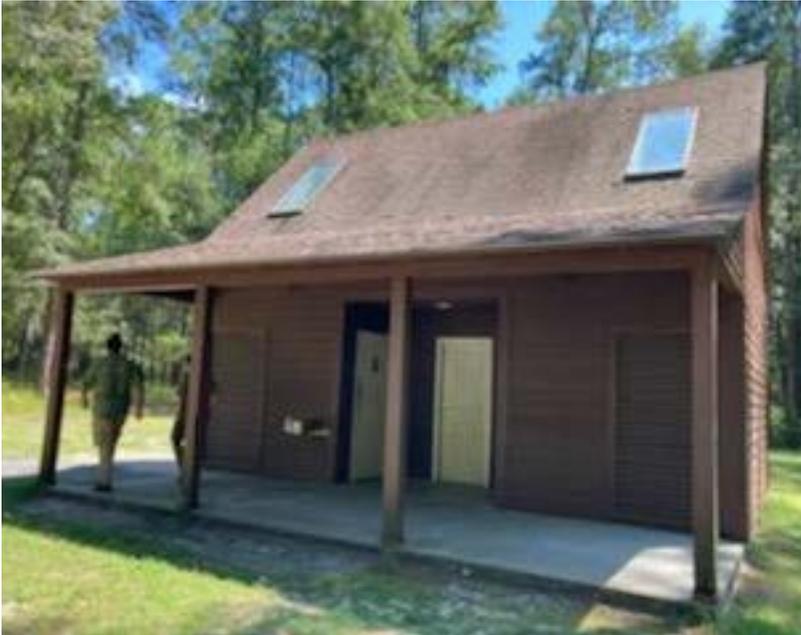
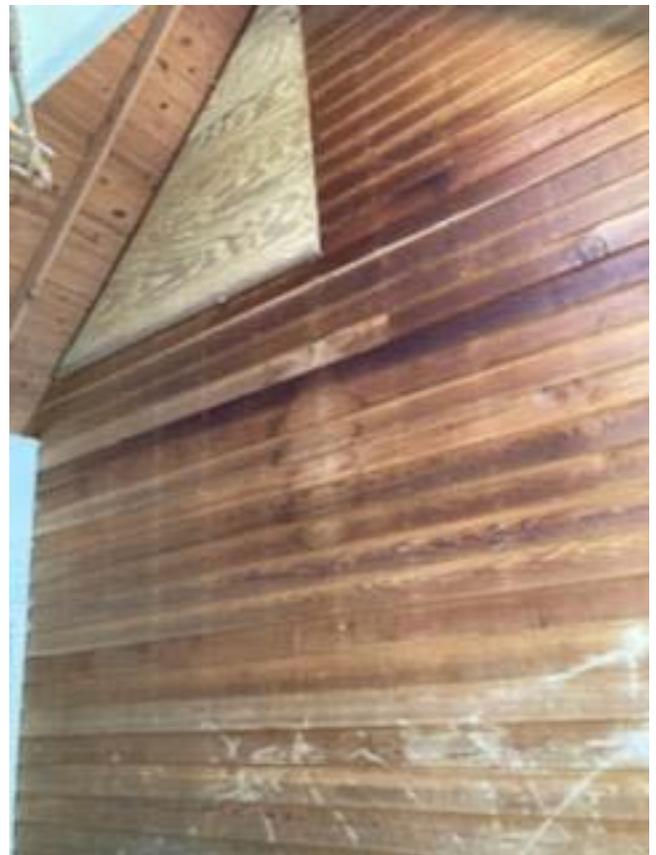
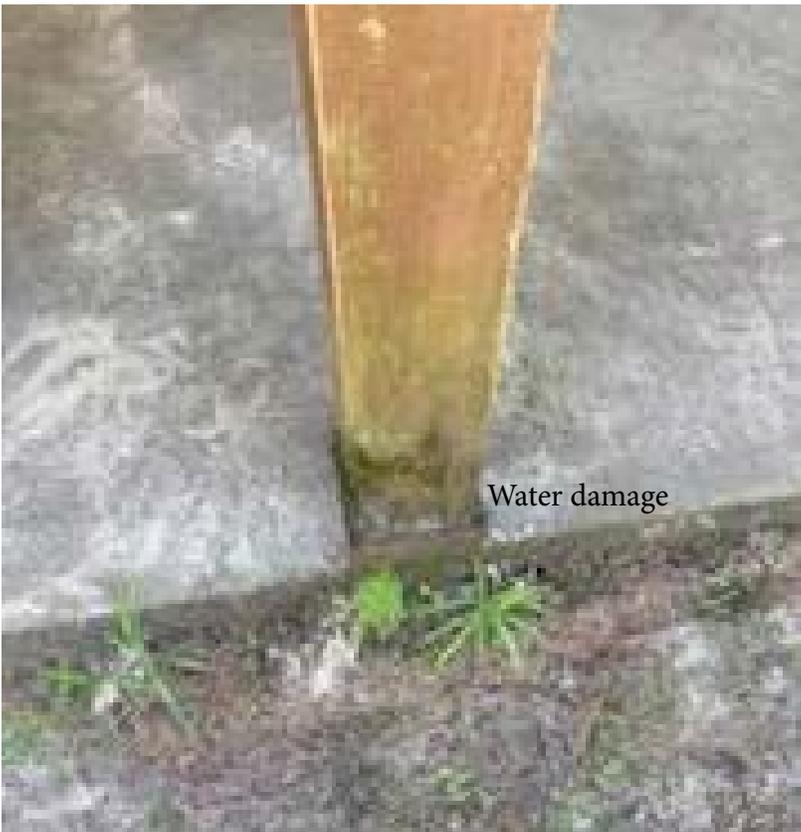
GMP PROJECT #7: PROPOSED RESTROOM AT SWIM BEACH

The restroom building at the swim beach has exceeded the expected lifespan. The structure will be raised to prevent water damage from to sea level rising and the intensity and frequency of storm events.

The existing bathhouse is over 35 years old and needs to be replaced. Prior to construction, the consultant will evaluate the feasibility and cost analysis of purchasing and installation of a prefabricated structure. Prior to design, the finished floor elevation will be determined based on the flood elevation and projected sea level rise.

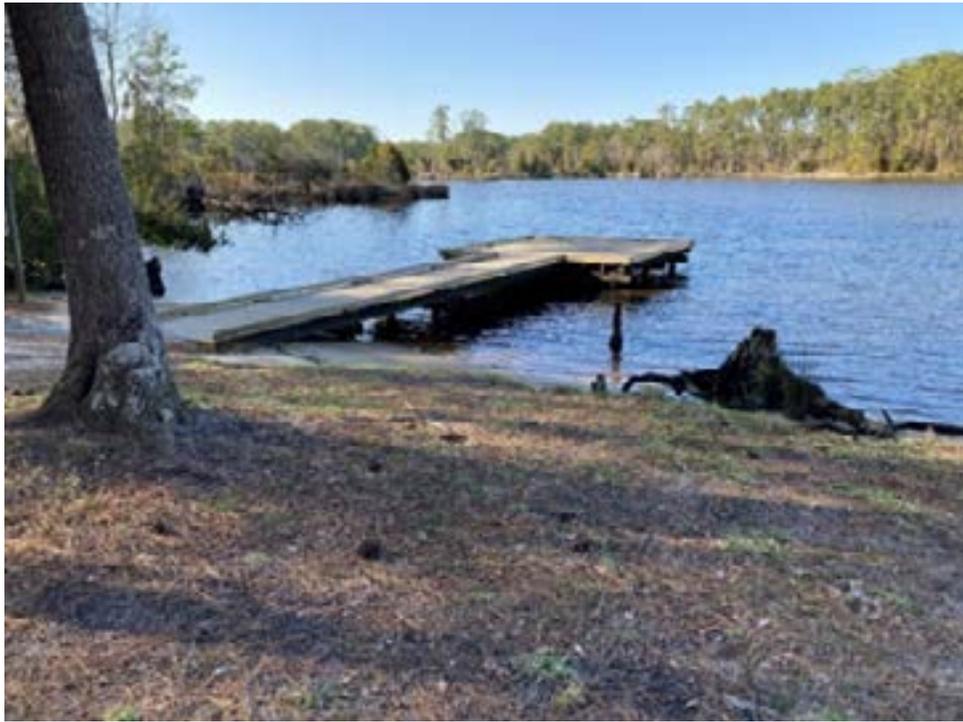
Structure will be similar to the existing non motorized boat launch at primitive campground

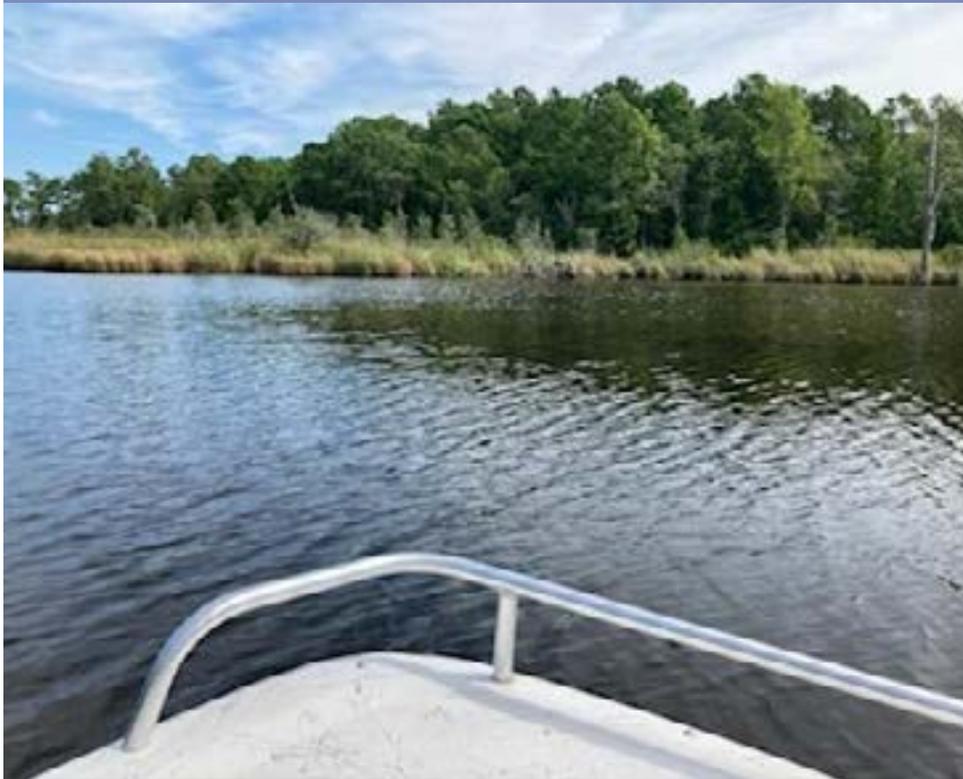
Location of proposed water access along existing shoreline

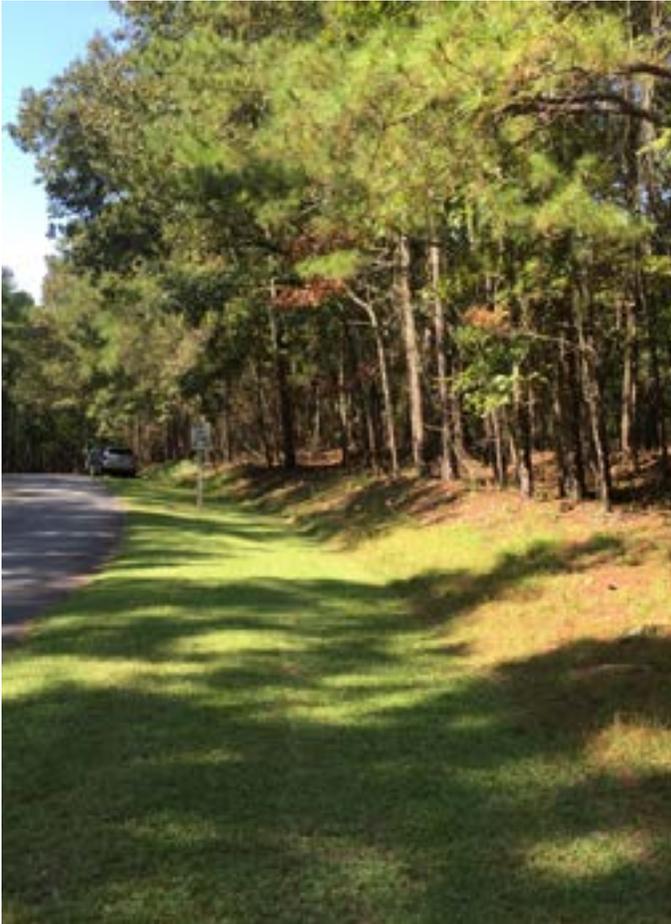
GMP PROJECT # 9: ROADWAY IMPROVEMENTS

The park managed roads needs an asphalt overlay in order to provide adequate weight for heavy duty equipment, including construction and prescribed burning equipment

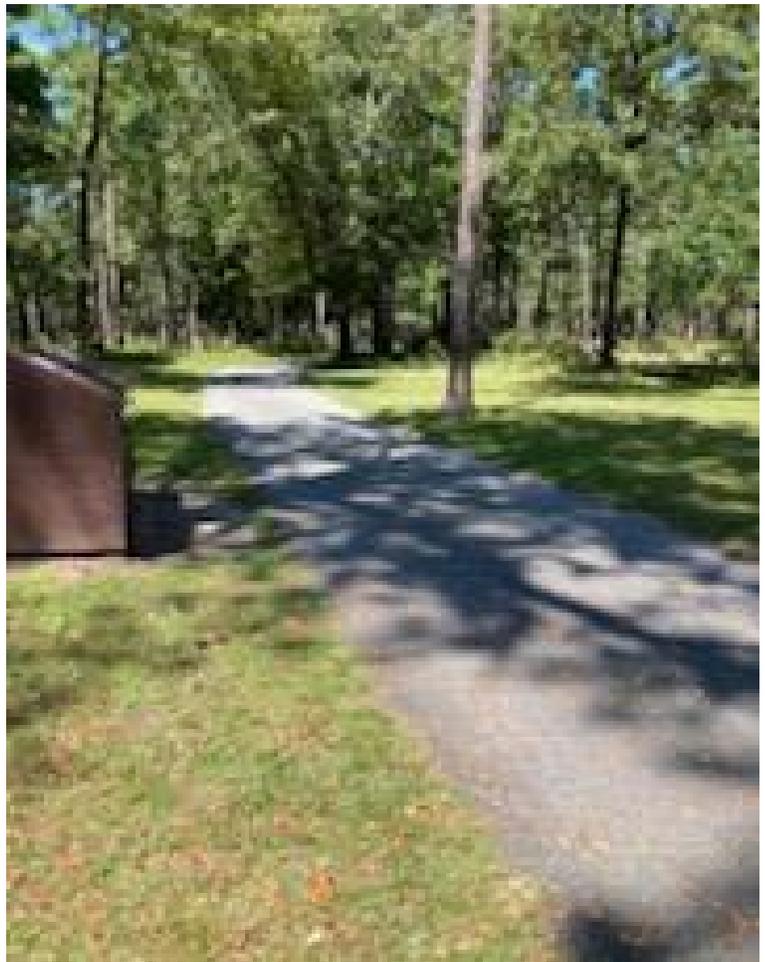
Multi use trail needs to a 1" asphalt overlay in order to be accessible compliant
