Goose Creek State Park General Management Plan

*North Carolina Department of
Natural and Cultural Resources
Division of Parks and Recreation*

*Coastal Region
May 2023*

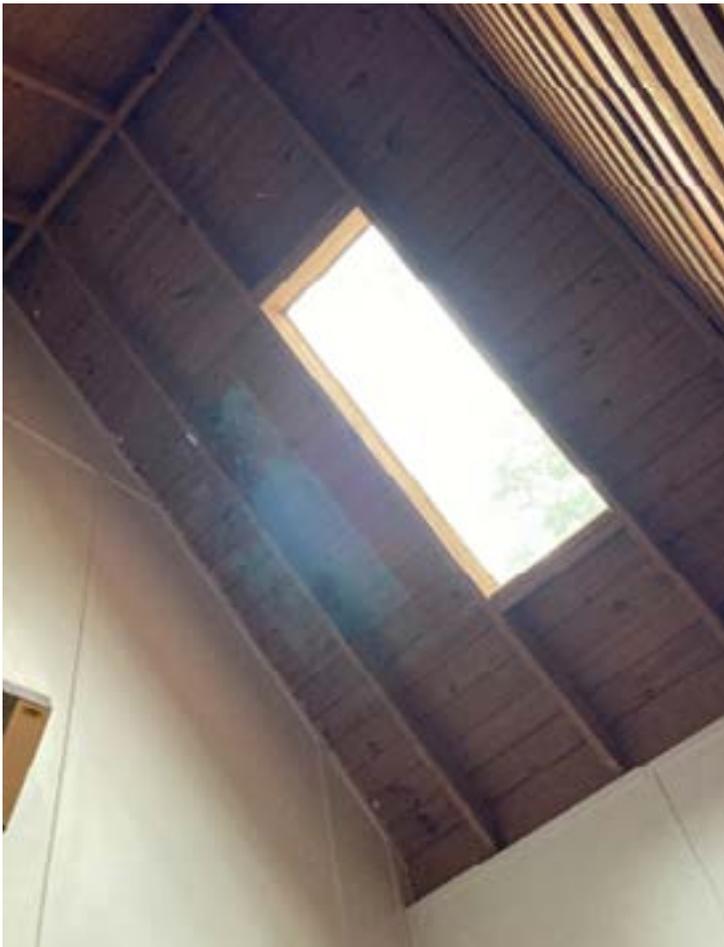
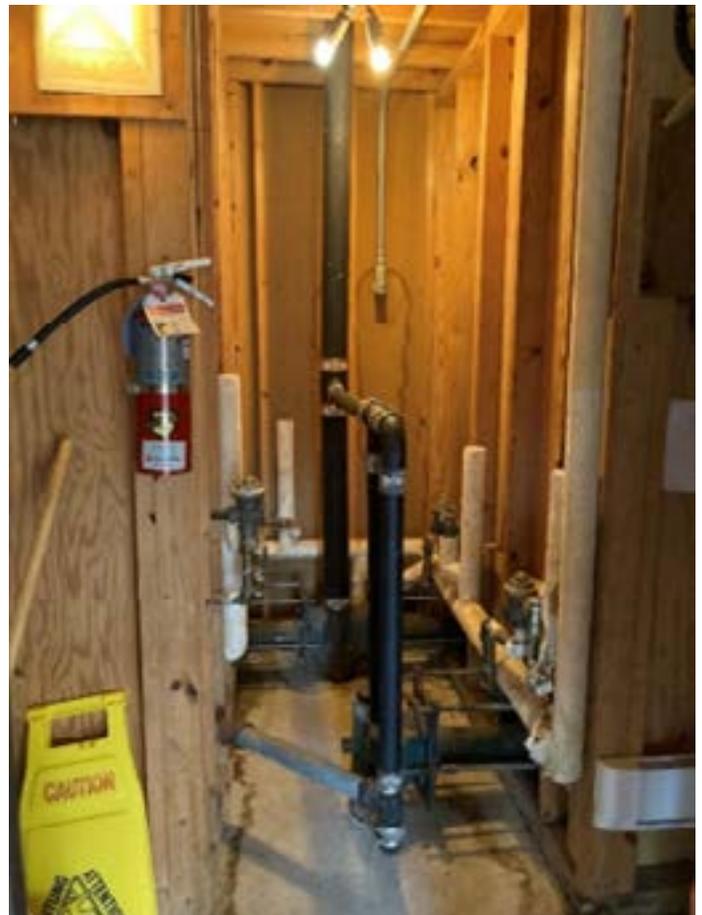
GMP PROJECT #12 - PROPOSED RESTROOM BUILDING AT GROUP CAMPGROUND

The restroom building at the Group campground has exceeded the expected lifespan. The structure will be raised to prevent water damage caused by relative sea level rising, intensity and frequency of storm events.
