Hanging Rock State Park General Management Plan

North Carolina Department of
Natural and Cultural Resources

Division of Parks and Recreation

October 2020

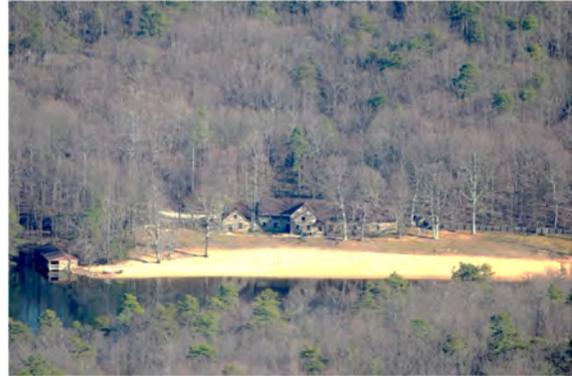
Hanging Rock lake is a manmade structure that provides a stormwater impoundment device along with a swim beach and depression era bathhouse

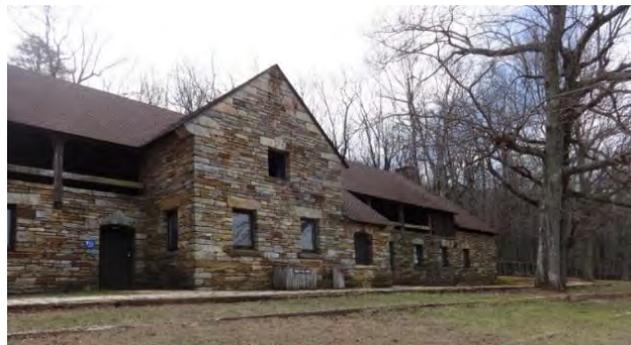
The 12-acre manmade lake and bath house was constructed by the Civilian Conservation Corps in 1938

In 1936, the Stokes County Committee for Hanging Rock and the Winston-Salem Foundation donated 3,096 acres of land to the State of North Carolina for establishing a State Park unit. Many facilities in the park were constructed by the Civilian Conservation Corps (CCC) between 1933 and 1942 including: a concrete and earthen dam, a stone bathhouse, diving tower and sandy beach. Other facilities constructed by the CCC include a park road and parking area, a picnic area and shelter, and hiking trails. The bathhouse was added to the National Register of Historic Places in 1991.

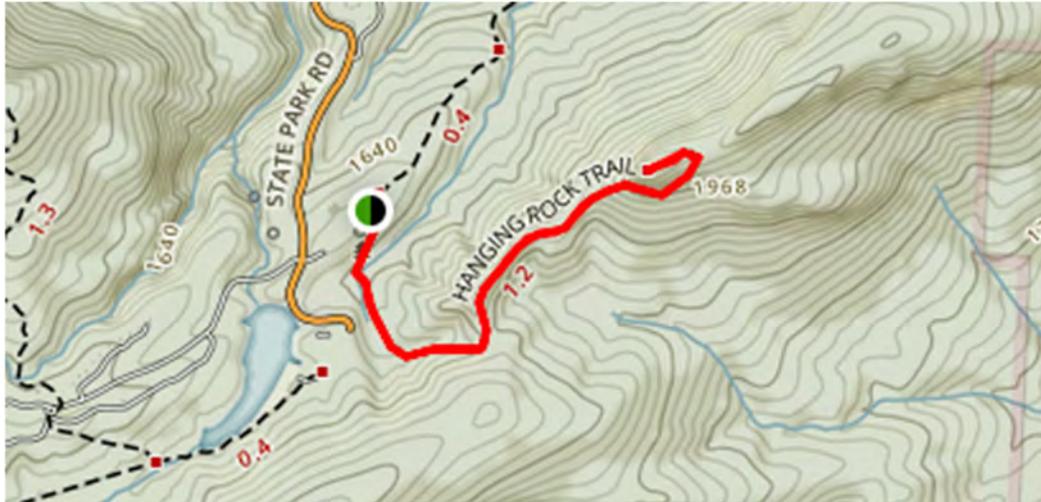
Existing Hanging Rock Trail alignment

Hanging Rock Trail to the overlook needs to be redesigned to provide emergency access due to multiple injuries and heavy usage. Trails staff will design an alignment trail built to sustainable design standards and practices.

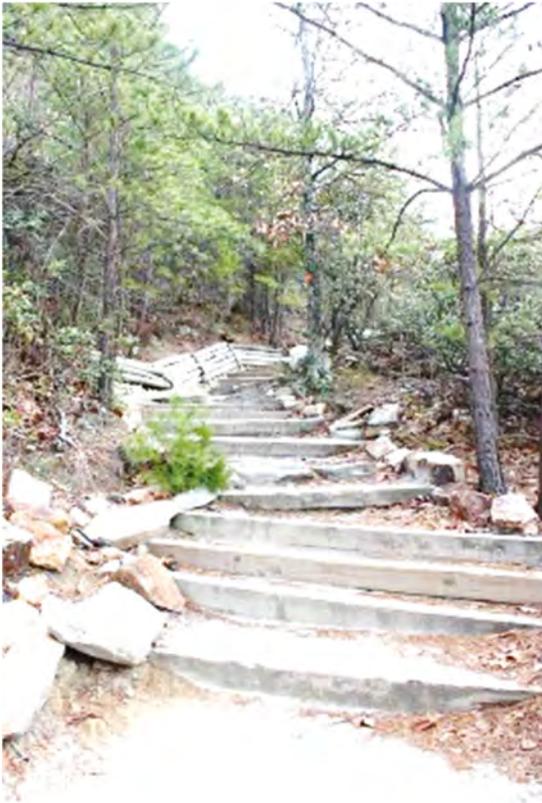
Existing timbers have a 6" riser and 6" platform becomes a trip hazard. Stone edging is inconsistent

- Selective tree clearing,
- Minor grading diversion ditches will provide adequate drainage
- Install stone steps (field verify)
- Construct Re-routes using sustainable design standards
- Erosion control measures
- Stormwater management devices (as needed)
- Re-establish understory with native species

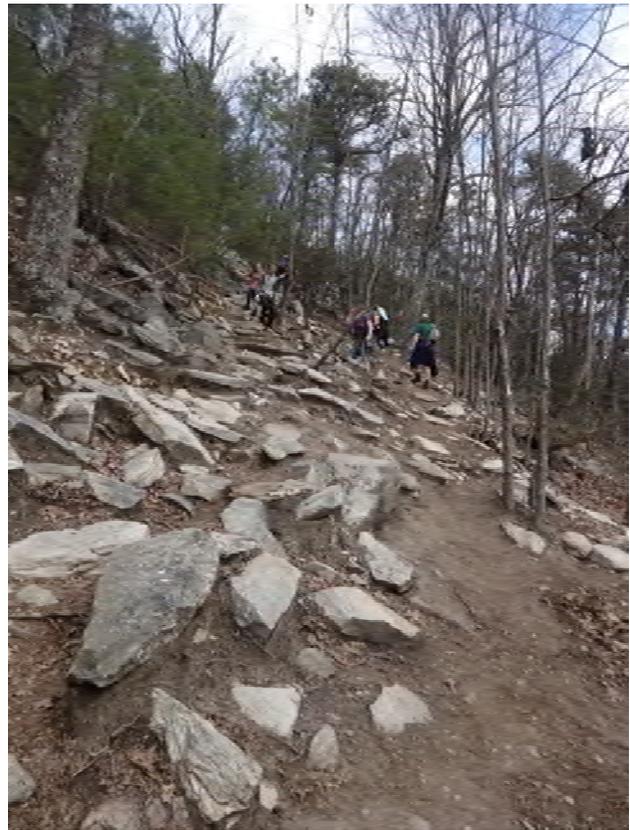
Existing trail on a 3:1 slope needs to be re routed

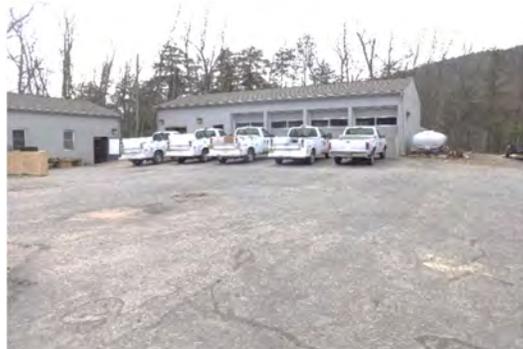
Need additional staff parking located close to the maintenance facility

The maintenance area pavement is over 30 years old, and needs to be repaired in order to provide a safe working environment for park staff. This park manages and maintains over 8,837 acres.

- Install 3 bay pole barn
- Storage for materials
- Additional staff parking spaces (5)
- Install Storm drainage and construct parking lot to sheet flow to diversion ditch
- Coordinate with NCDOT to repair and repave asphalt

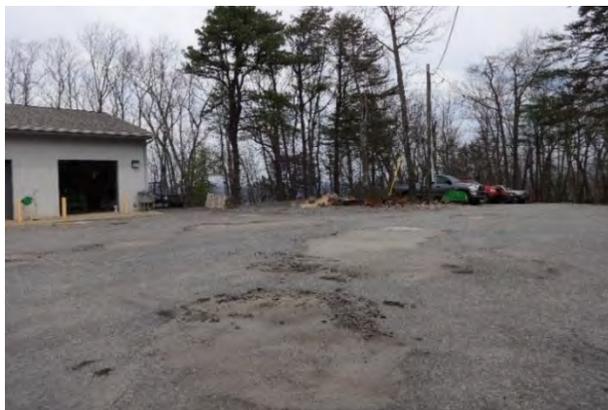
Existing asphalt needs to be regrading for positive drainage. Need to install asphalt paving, provide staff parking and an area to store materials.

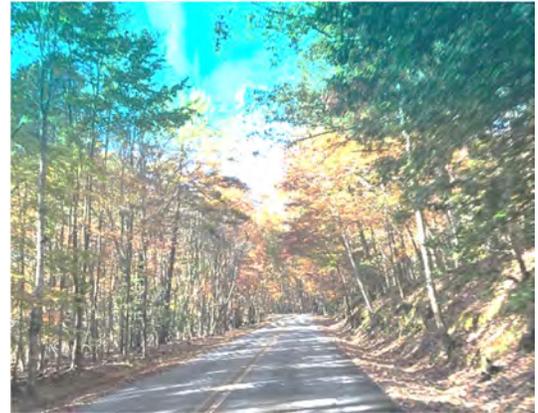
The road system is in poor shape due to tree roots and rocky soils causing pavement cracking and upheavals. Park staff will coordinate with NCDOT.

Hanging Rock State Park Road needs to be repaved due damage from tree roots

- Maintenance area parking lot
- Hanging Rock State Park road. - resurface and stripe
- Clear and realign drainage ditches to create positive drainage.
- Campground Road
- Remove tree roots prior to resurfacing.
- Replace damaged stone curbing (2,500 feet) in the visitor center parking lots (field verify).

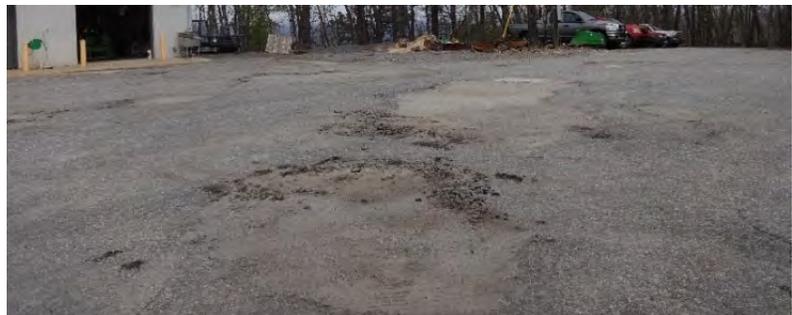
Existing Maintenance area needs grading, re-pavement and paint striping

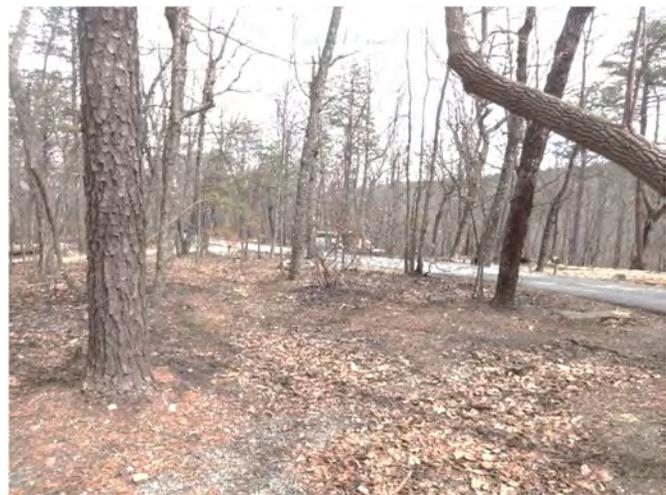
Campground Road is very narrow, and pavement has been damaged from tree roots

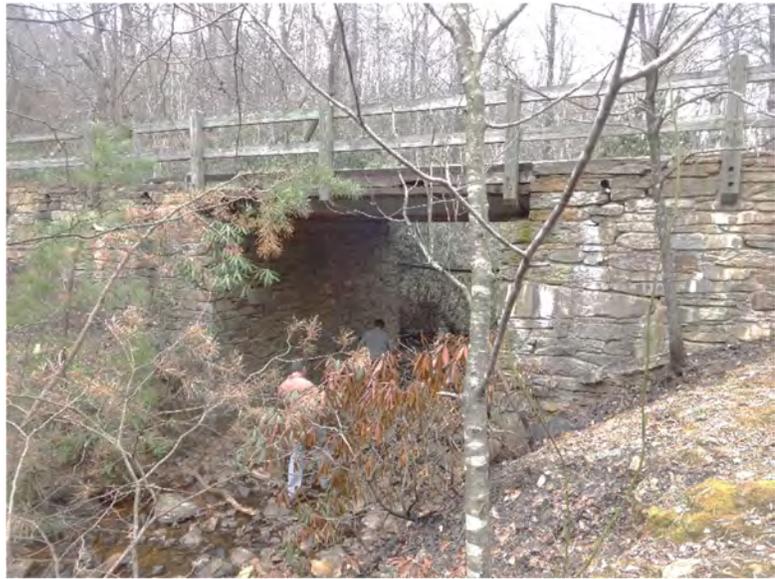
Campground bridge needs additional structural beams

- Upgrade campground road bridge prior to campground improvement project occurs. Install structural beams to support construction equipment will be used to improve the campground.
- Repair and tuck point the stone veneer around the abutments and walls.

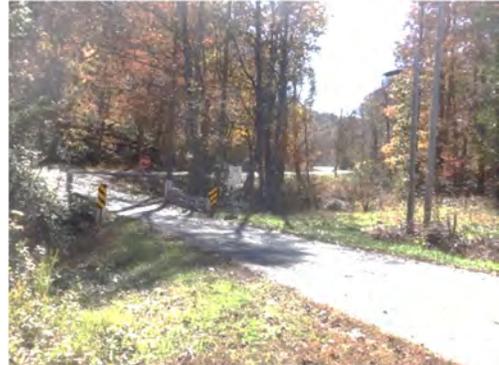
Orrell Road Bridge does not have enough weight capacity to carry construction equipment or RV's

Staff will coordinate with NCDOT to remove and replace the existing Orrell bridge. The bridge needs to be reconfigured to a ‘T-intersection’, widened to 30’ and provide adequate weight capacity for grading equipment, emergency access and recreational vehicles (RV’s). This project will establish a safe intersection for the future campground improvements.

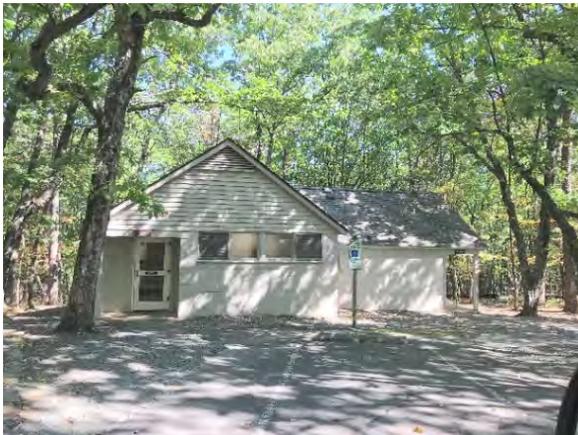
Front elevation of existing lower shower house

- Demolish existing shower house
- Construct an accessible pathway from parking space to entrance of new shower house
- Reuse existing 5,400-gallon septic tank or new construction based on the subsurface utility engineering (SUE) assessment survey
- Hook up utilities to existing connection
- Install area for washing station

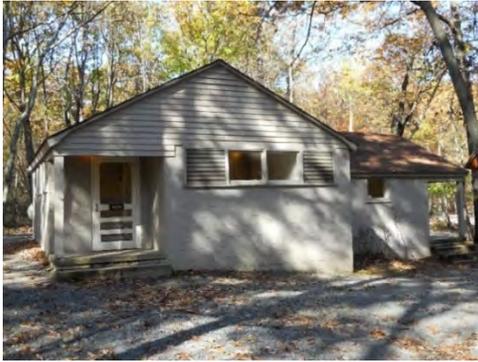
Side view of upper shower house

- Demolish existing shower house
- Construct an accessible pathway from parking space to entrance of new shower house
- Reuse existing 5,400-gallon septic tank or new construction based on the subsurface utility engineering (SUE) survey and recommendations
- Hook up utilities to existing connection
- Install area for washing station for washing dishes or clothes.

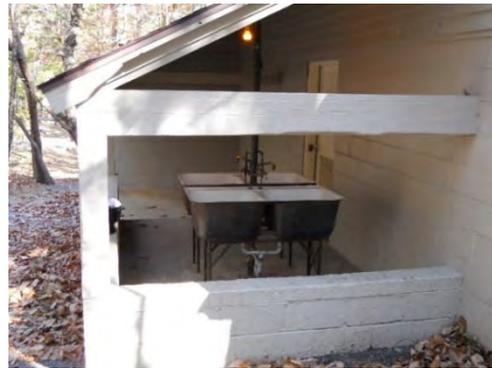
Wash station

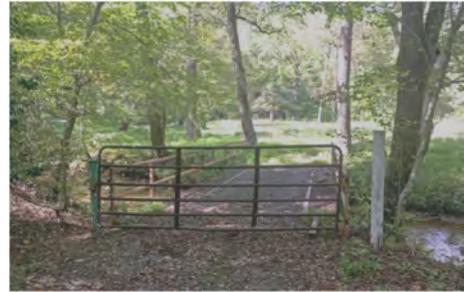
The existing vehicular bridge does not meet design standards for emergency access. The bridge needs to be removed and replaced with a prefabricated metal span bridge and concrete abutments.

Existing vehicular bridge across Cascade Creek

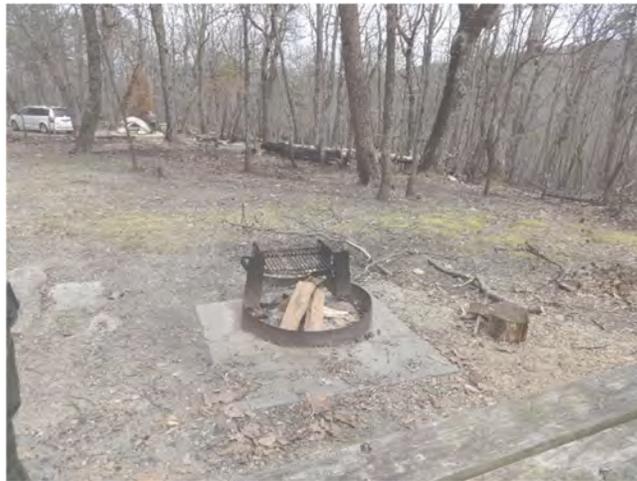
Existing Firepit needs to be integrated into the impact pad area

- Tree clearing and stump grinding as needed
- Pave and widen 20' wide driveway with asphalt or reinforced concrete
- Accessible parking spaces (as needed)
- Install Impact pad: granite screenings and timber
- Install Fire rings
- Install picnic tables
- Provide trail connection to shower house

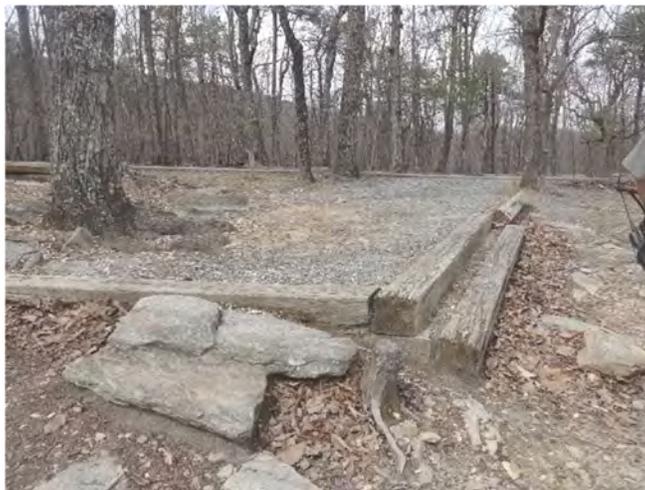
Existing impact pad needs replacement of timbers

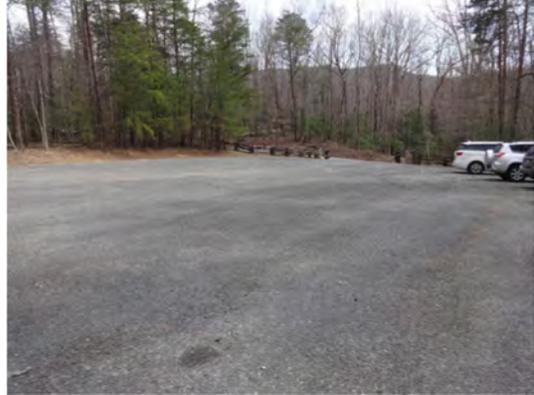
Parking lot has poor drainage and asphalt is crumbling

- Grade for positive drainage,
- Installation shade trees
- Remove asphalt in order to construct tree islands
- Install concrete wheel stops to designate parking space

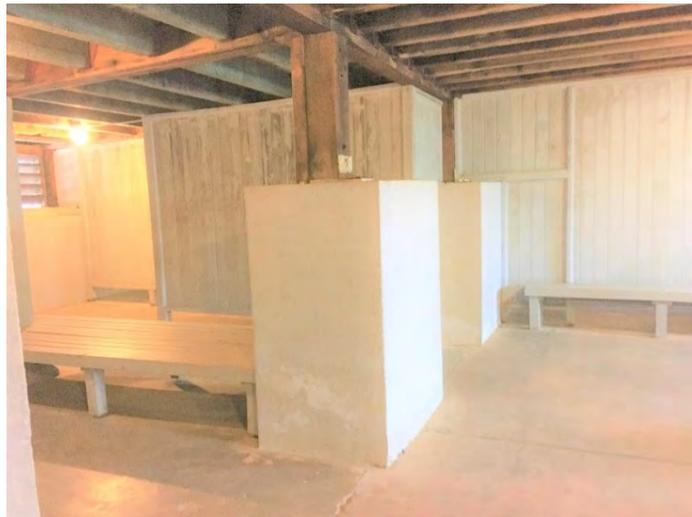
PROJECT #5: BATHHOUSE AND SWIM BEACH IMPROVEMENTS

Diving platform needs structural assessment report and recommendations

- Architectural assessment report
- Structural assessment report for diving platform
- Insulate windows
- Inspect floor drains and outlet
- Inspect plumbing for connections and leaks
- Install stormwater improvements and roof water drainage
- Install prefabricated trench drain system
- Install erosion issues on swim beach
- Make repairs to diving platform based on structural assessment recommendations
- Repair dam structure

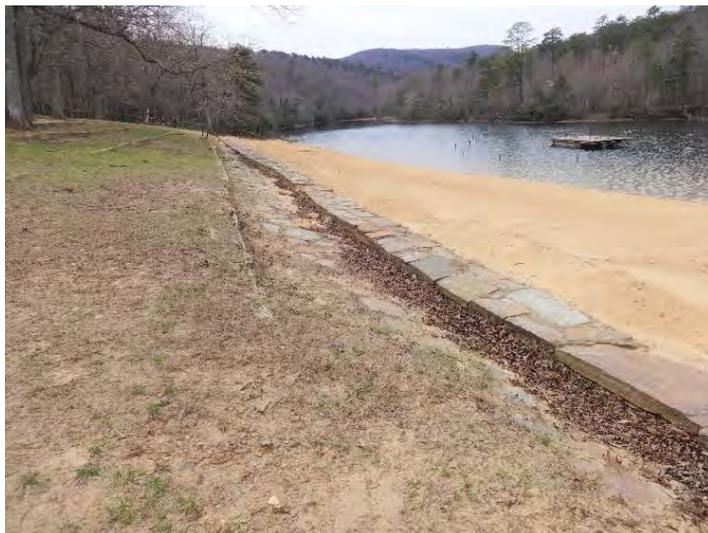
Swim beach needs erosion control devices designed and installed

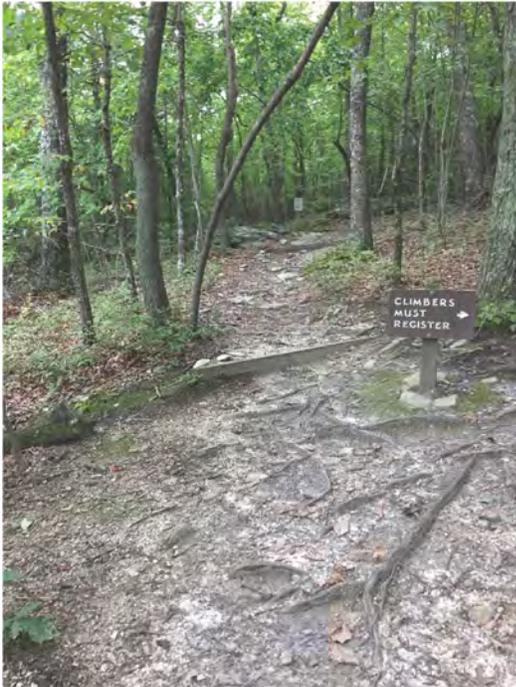
PROJECT #20: MOORE'S WALL CLIMBING ACCESS AREA

Route to Moore's Wall climbing access area

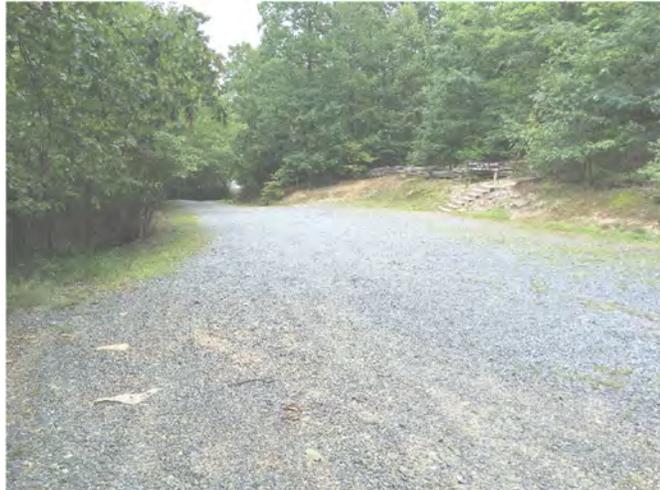
Install wheel stops to define parking spaces and provide emergency access
