10 SUSTAINABLE DESIGN IN STATE PARK MASTER PLANNING

ASSESSMENT OF EXISTING STRUCTURES

at Long Valley Farm

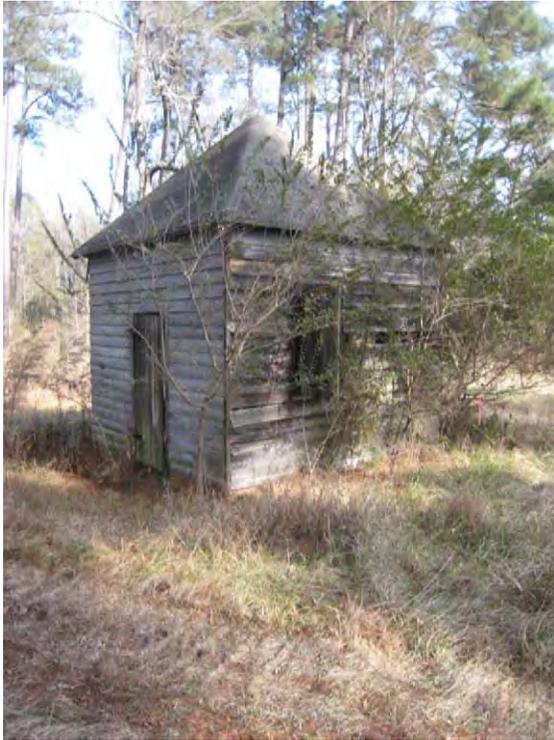
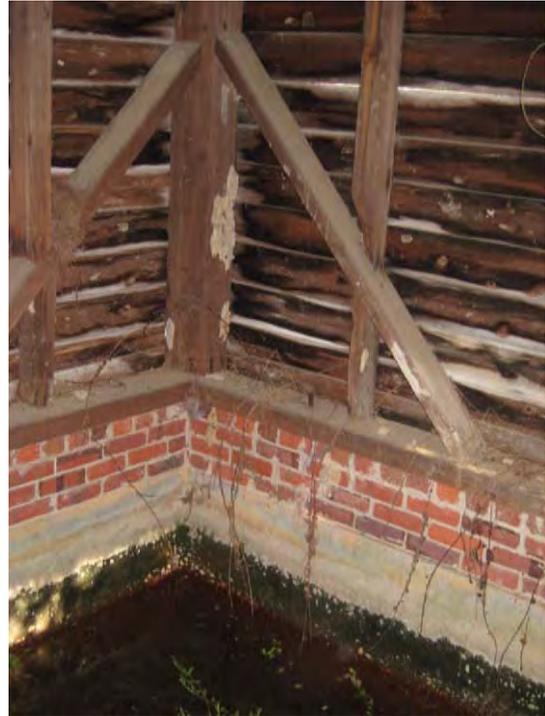
2. SPRINGHOUSE

Foundation System: concrete footing, masonry apron
Condition: fair
Notes: overgrowth on both inside and outside

Cladding System: 2x6 horizontal wood lap board
Condition: poor
Notes: significant siding pull-out and rot, corner boards need replacing

FCAP Recommendation: drain water from concrete box, install cover; reattach and replace siding; trim back vegetation outside and inside

ECA Recommendation & Opinion of Project Cost:
1. Restore exterior, verify water tightness, make secure:
\$6,000

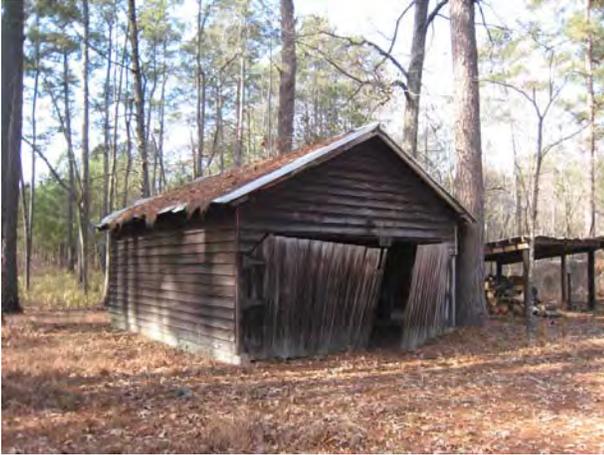
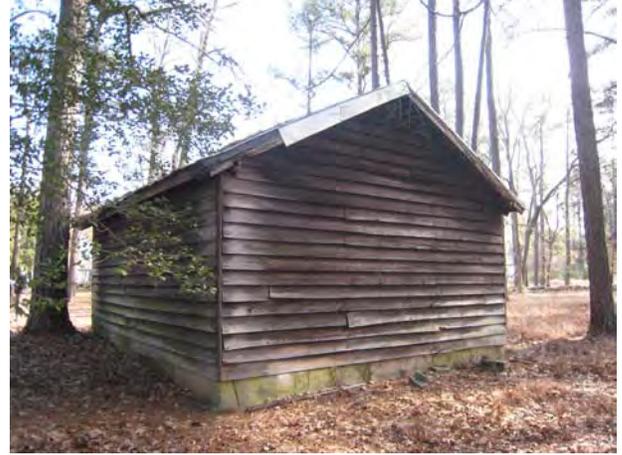
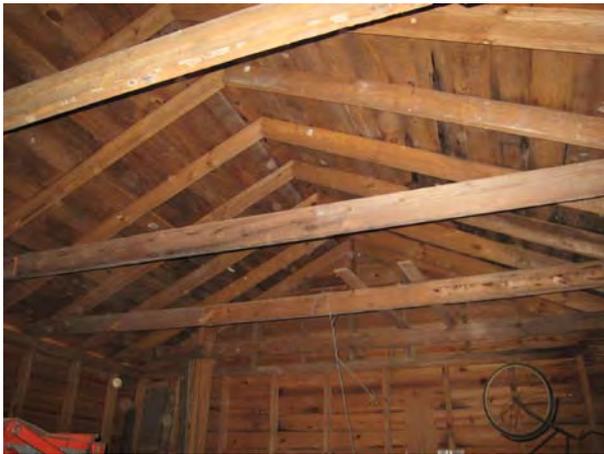
3. FARM SEAT GARAGE

Foundation System: concrete apron perimeter footing with a dirt floor
Condition: fair
Notes: cracks and plant growth

Structural System: 2x4 wood frame
Condition: good
Notes: one leak, but no major flaws

Cladding System: horizontal wood lap board
Condition: fair
Notes: some pull out

Roof System: joists and rafters with metal roofing
Condition: fair
Notes: one visible leak

FCAP Recommendation: renovate and restore to historical quality

1. Repair exterior siding, reinforce roof and patch, fix door: \$12,000

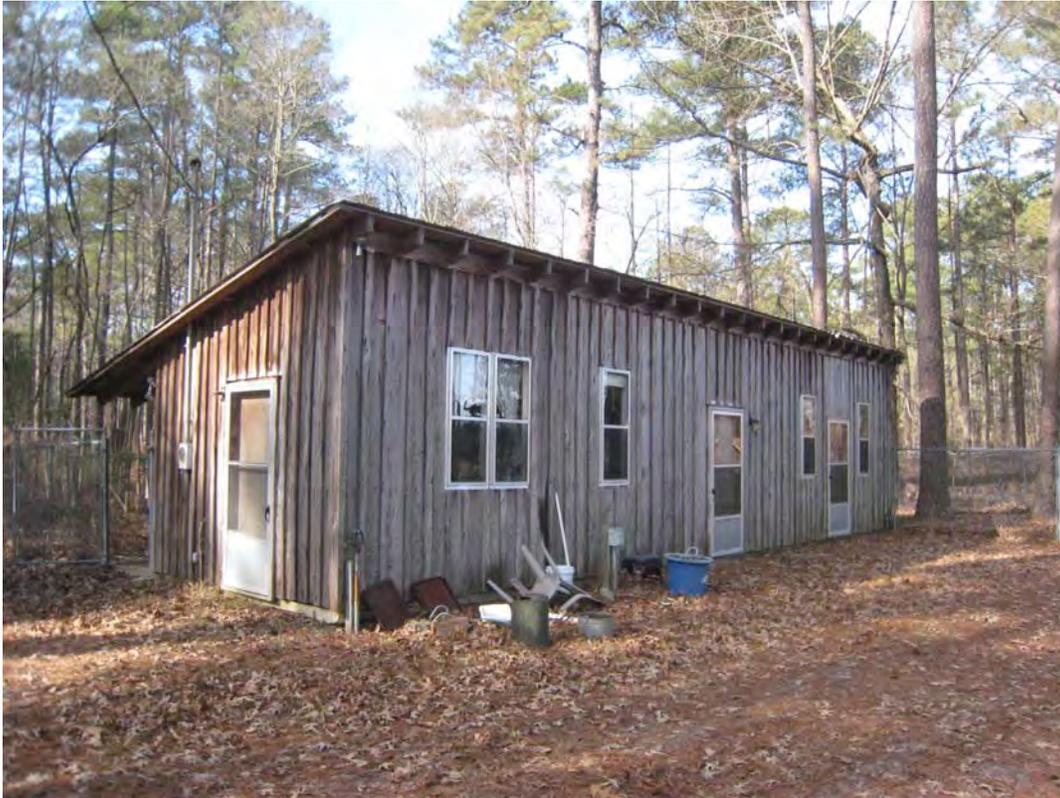
5. KENNEL

Foundation System: concrete slab

Notes: some cracking

Notes: areas of rot and pull out

FCAP Recommendation: demolish structure and grade site to safe condition

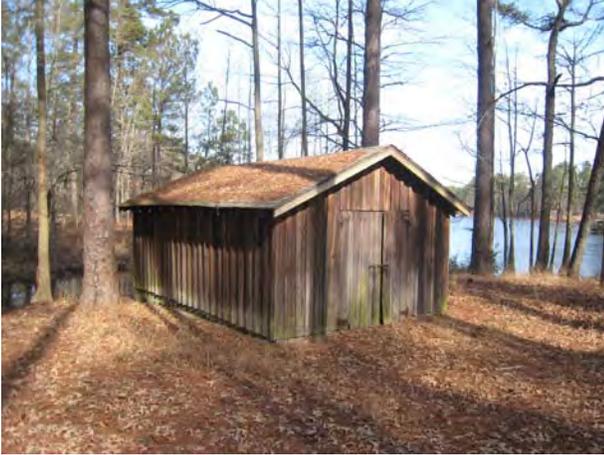
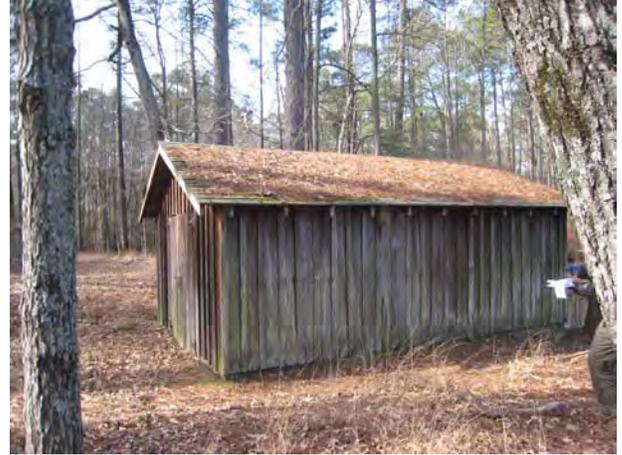
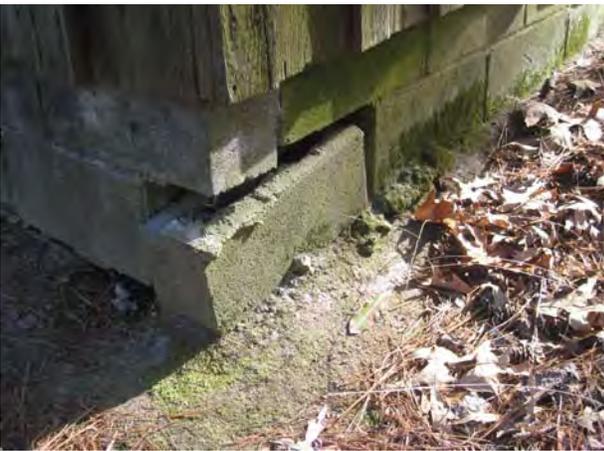
6. BOATHOUSE

Foundation System: cinder block on ground
Condition: poor
Notes: some blocks falling off (see image above)

FCAP Recommendation: demolish structure and grade site to safe condition

1. Demolish and reclaim siding: \$4,000
2. Repair foundation, mold damage, and shingles for use as boat or general storage: \$3,000

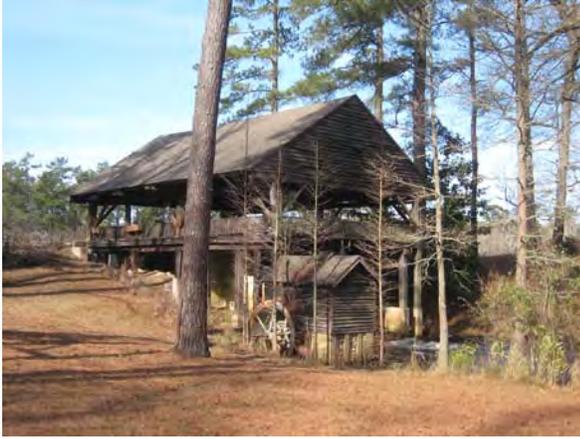
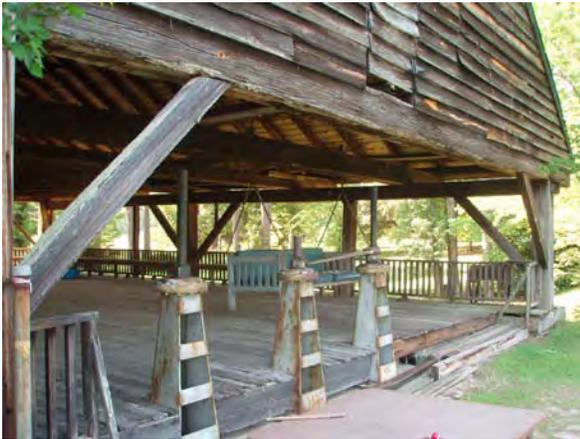
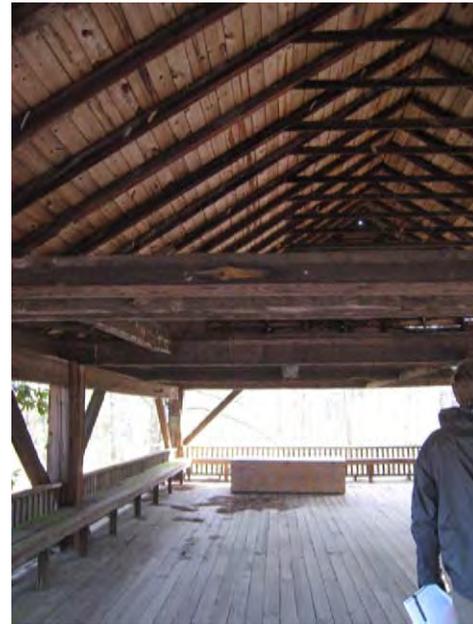
8,9. MILL PAVILION + DAM GATES

Structural System: timber frame
Condition: fair
Notes: uprights are 14" square, cross beams are 12"x14"

Cladding System: horizontal wood lap board
Condition: poor
Notes: significant holes and pullout

Roof System: joists and rafters with asphalt shingles
Condition: poor
Notes: significant bows in roof and flitch splicing on inside

Floor System: overspanned wood boards on joists
Condition: fair
Notes: though structurally intact, the floor is unsafe for high occupancy

FCAP Recommendation: trim vegetation back; repair or replace deteriorated siding, flooring, railing, and structural members; re-grade perimeter to prevent erosion; upgrade and rewire electrical systems

1. Structural analysis for safety: \$2,000
2. Repair siding and roof, rebuild floor, trim vegetation, re-grade perimeter, upgrade electrical, make ADA accessible: \$110,000

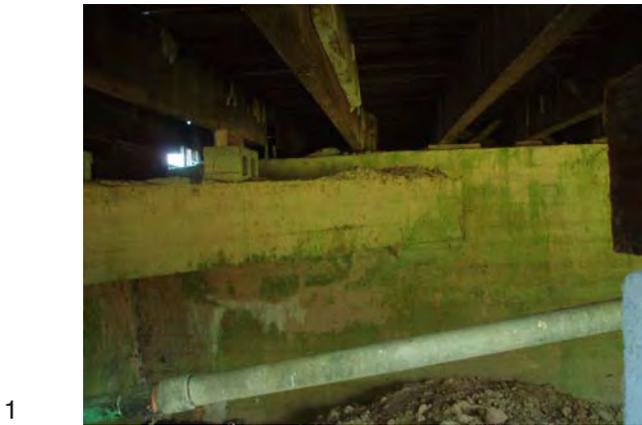
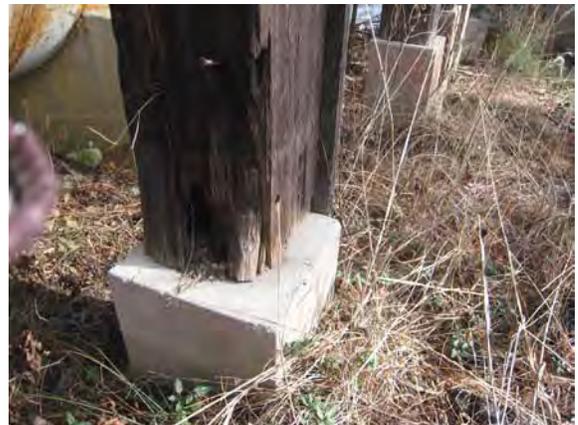
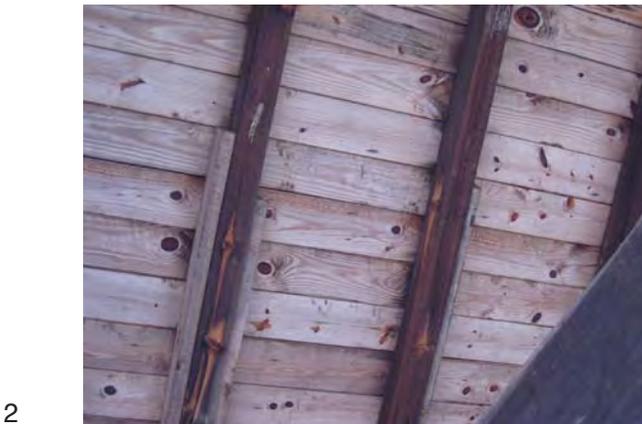
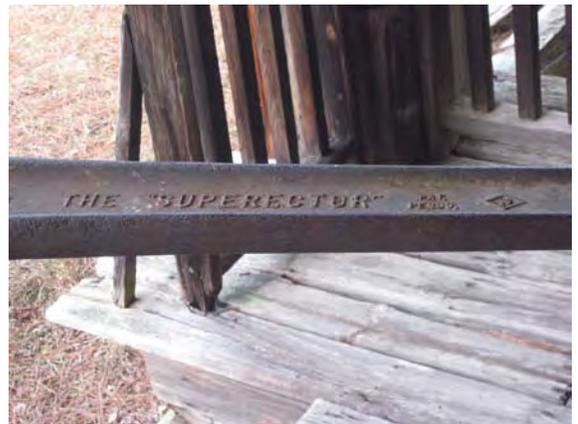
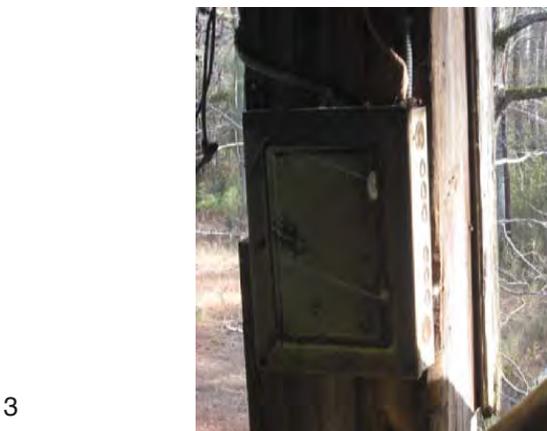
1. foundation with moss growth
2. flitch splicing roof rafter
3. electrical box

4. concrete pile foundation
5. lever arm for dam gate

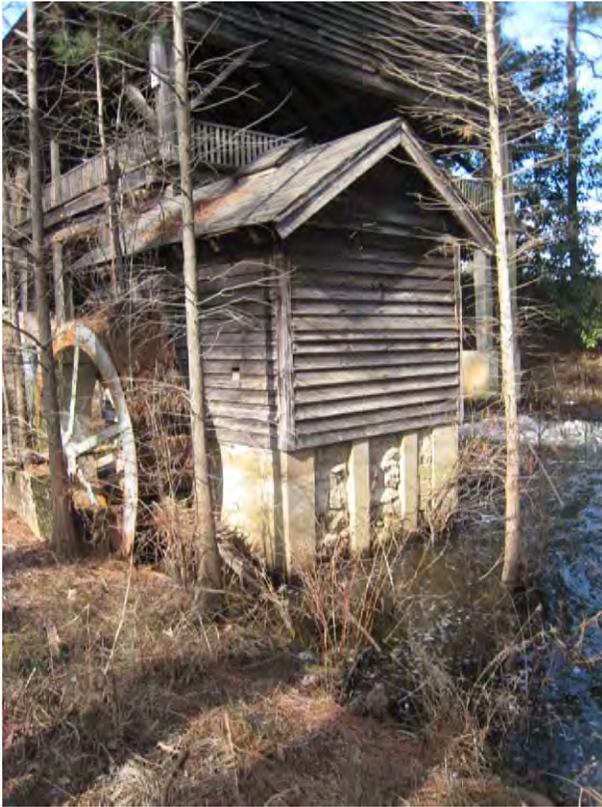
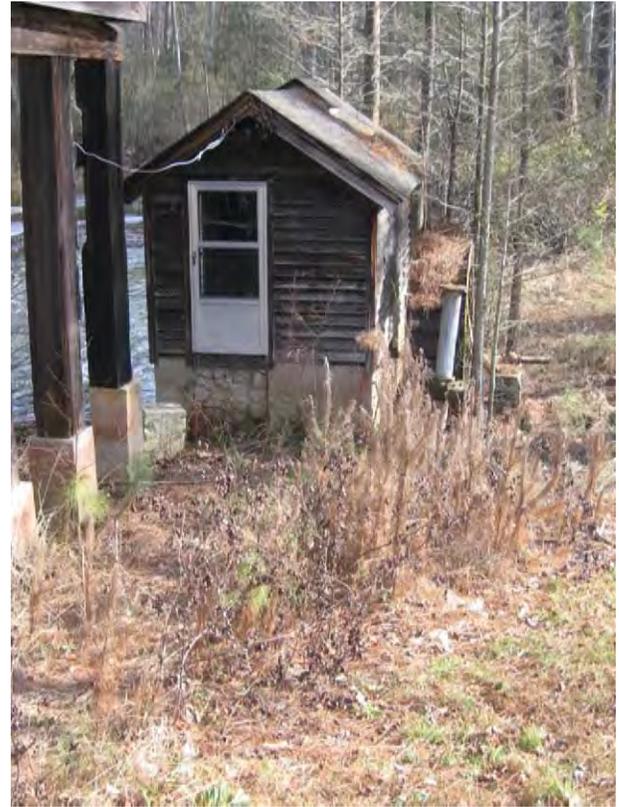
10. PUMP HOUSE

Notes: some debris and stains on roof

FCAP Recommendation: trim back vegetation; reattach or replace deteriorated siding and door; sandblast water-wheel and finish both wheel and housing

1. Trim vegetation, repair exterior, remove screen door, make secure, sandblast and refinish water-wheel (non-operational) \$15,000

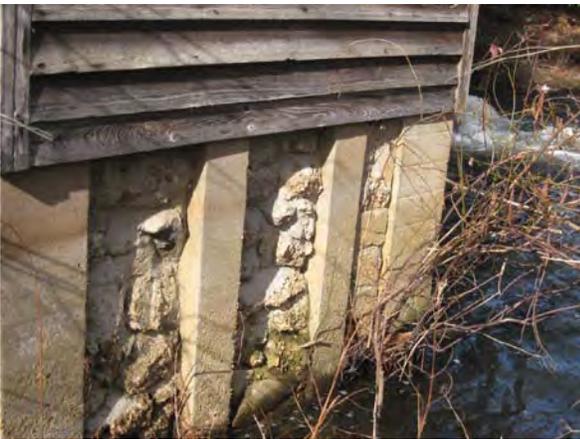
1. foundation
2. eletrical connection

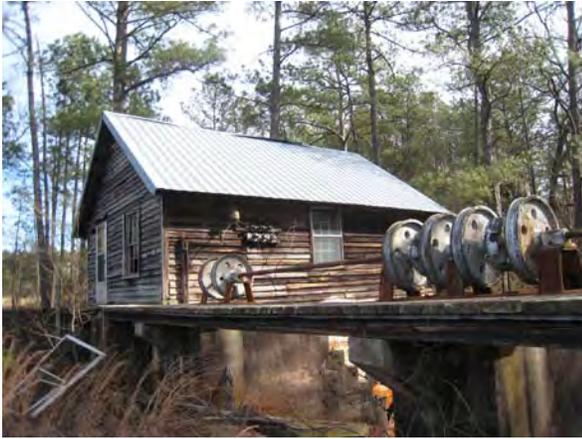
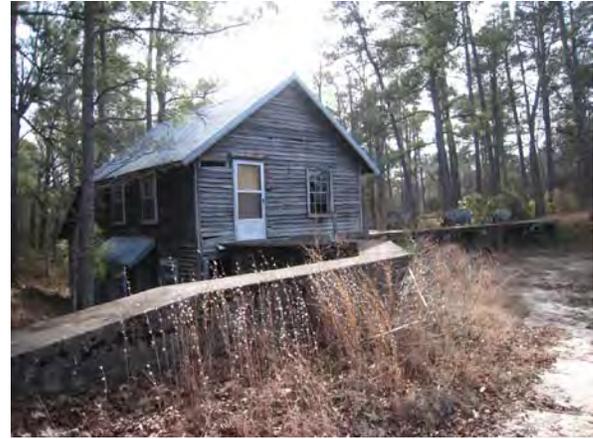
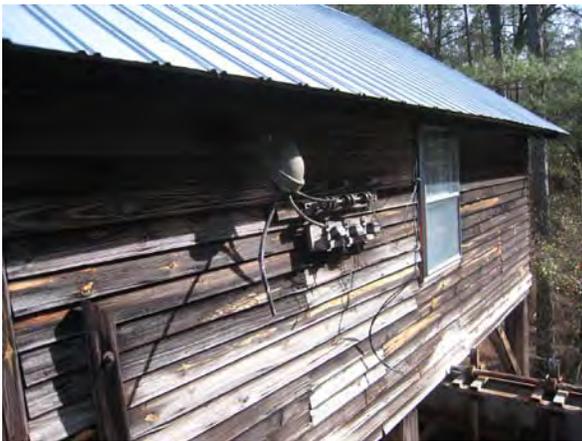
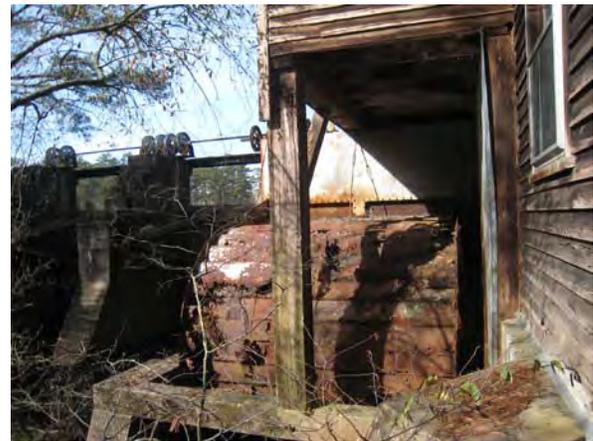
12. MILL HOUSE & GATES

Foundation System: poured concrete slab
Condition: fair
Notes: some cracking, chipping, moss growth on inside

Cladding System: horizontal wood lap board
Condition: very poor
Notes: holes, pull out, and moisture damage

Roof System: joists and rafters with metal roofing
Condition: good
Notes: new roof (unknown date), minor repairs needed

FCAP Recommendation: renovate structure to historical quality, fence area to prevent unauthorized entry
FCAP Cost: \$600,000
FCAP: Priority: 5 years

ECA Recommendation & Opinion of Project Cost:
1. Repair exterior for exterior viewing only, non-functioning mill machinery, with ropes/fences to cordon off: \$100,000
2. Same as FCAP: Minimum of \$600,000 for historical quality renovation, still non functioning machinery.
3. Structural and historical review needed whether restored for exterior viewing only or for interior tours and operations: \$5,000. Please see note number 3 on page 2.

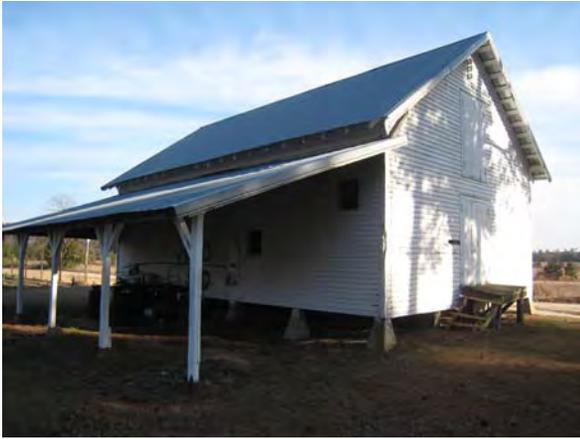
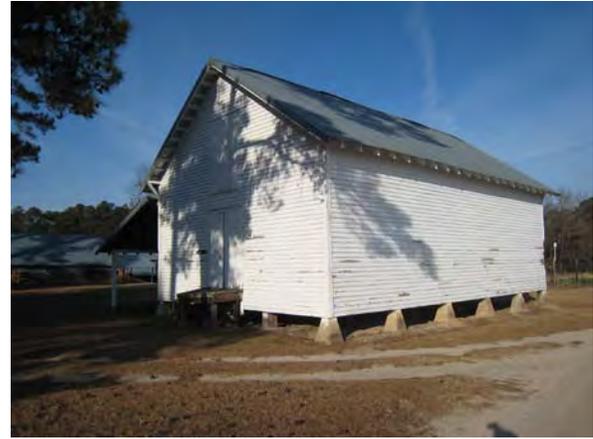
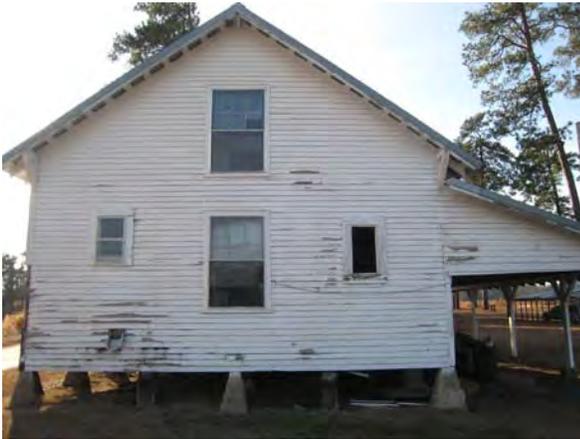
15. GRANARY

Cladding System: horizontal wood lap board
Condition: poor
Notes: paint peeling, corner boards missing, openings without glass

FCAP Recommendation: replace front entry platform, reattach or replace deteriorated siding; scrape, sand, clean, and paint siding; reattach and seal metal roof

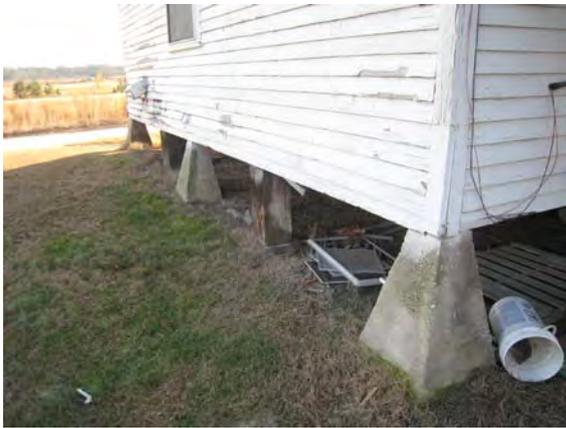
1. foundation
2. paint peeling from siding
3. entry porch damage, siding damage

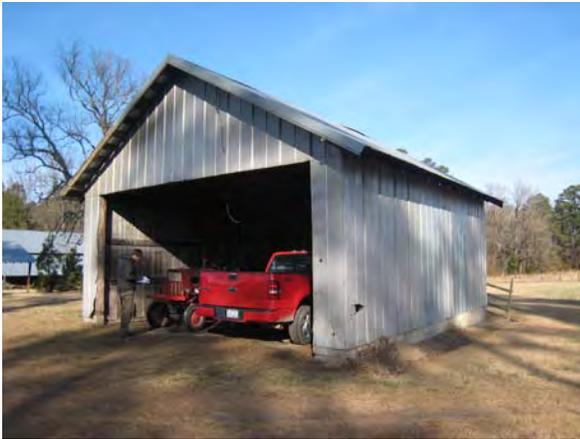
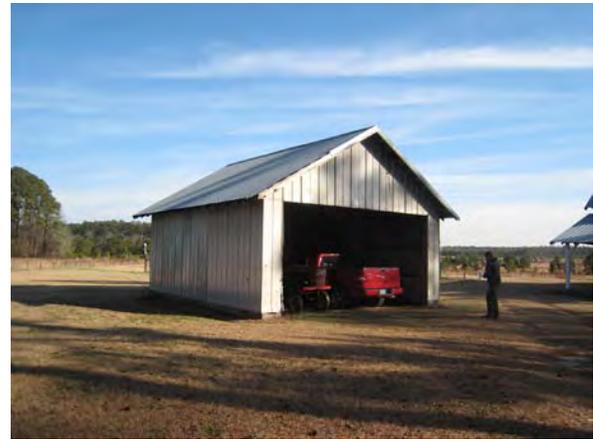
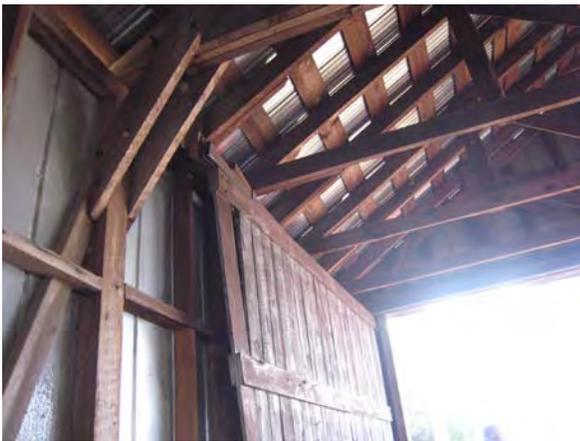
16. TRACTOR SHED

Foundation System: concrete block skirt
Condition: fair
Notes: some cracking

Cladding System: metal siding
Condition: fair
Notes: small holes, window with missing pane

1. Repair siding as needed: \$1,000
2. Cracked existing concrete slab could be replaced: \$2,000.
3. Additional electrical service and fans so that building could be rented or used for environmental education classes: \$6,000

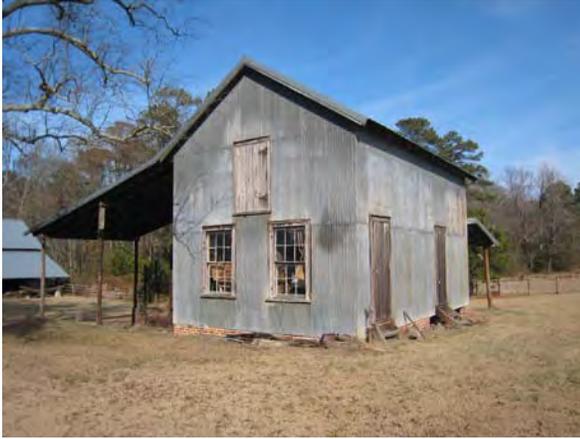
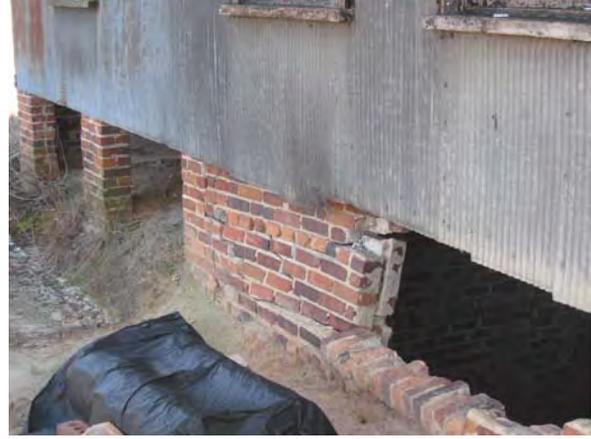
17. PACK HOUSE

Foundation System: masonry skirt and masonry pier
Condition: fair to poor
Notes: caving in at portions (upper right photo)

Cladding System: corrugated metal (vertical)
Condition: fair to poor
Notes: windows in poor condition, missing panes

Roof System: joists and rafters with metal roofing
Condition: fair to poor
Notes: east roof is giving way at corner

FCAP Recommendation: restore or replace entire structure

1. Repair exterior: \$15,000
2. Renovate interior, replace windows and doors: \$15,000
3. Add power, lighting, plumbing and HVAC if used for people: \$80,000

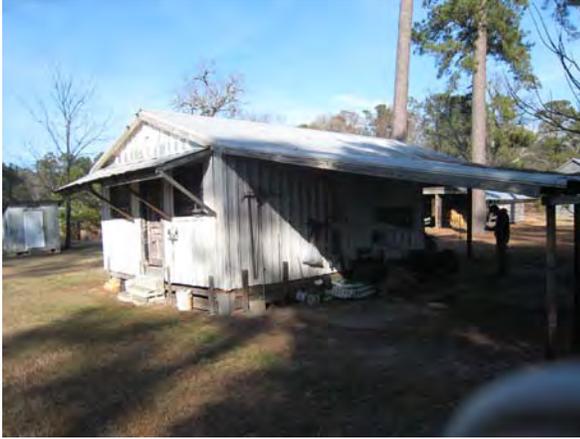
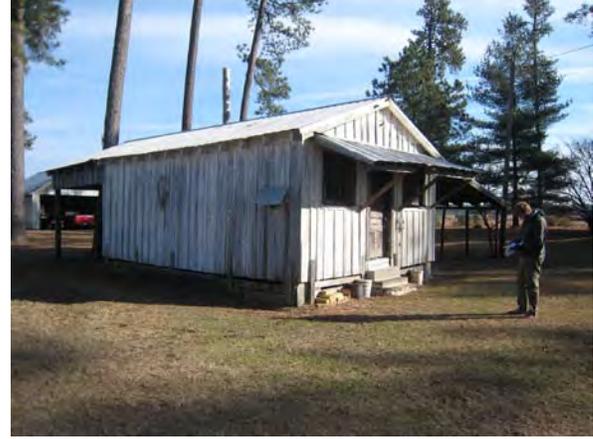
19. COMMISSARY

Roof System: rafters with metal roofing
Condition: fair
Notes: entry awning falling apart, shed rafters over spanned

1. Repair and repaint exterior, brace overhang, make secure: \$7,000
2. Repair interior and add fans (no HVAC) additional: \$3,000

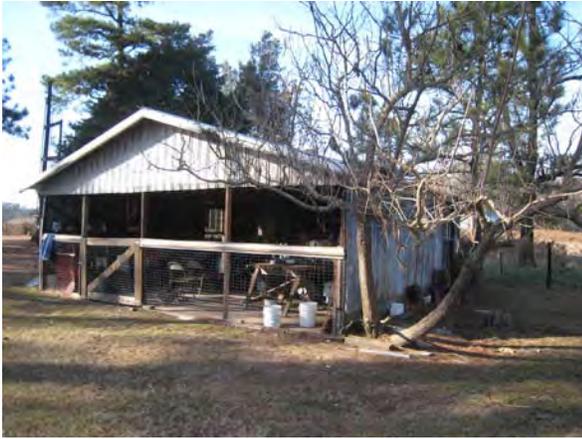
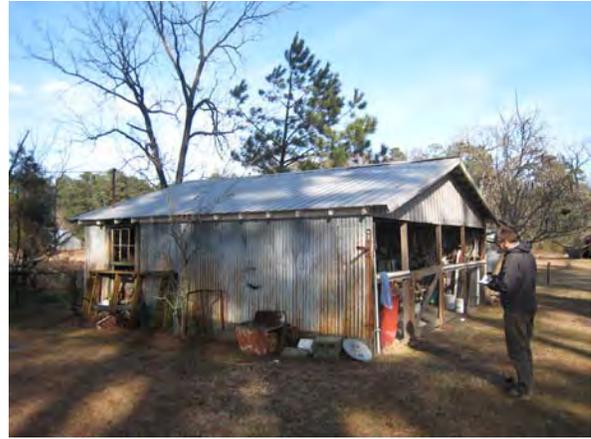
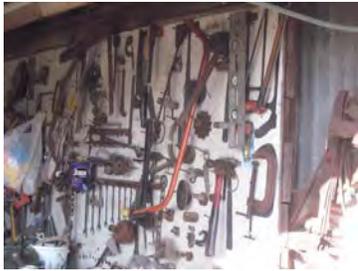
20. GARAGE / SHOP

Structural System: 2x4 wood frame
Condition: fair
Notes: 4' O.C. framing

Roof System: wood truss and metal roofing
Condition: fair
Notes: 4' O.C. framing

FCAP Recommendation: replace wood frame windows; scrape, sand, clean, and repaint siding; reattach and seal metal roof

1. Repair exterior, clean, remove tools, add lighting (assuming wiring works) and ceiling fans (no HVAC): \$10,000 This would still be a very rustic pavilion.
2. Demolish: \$2,000

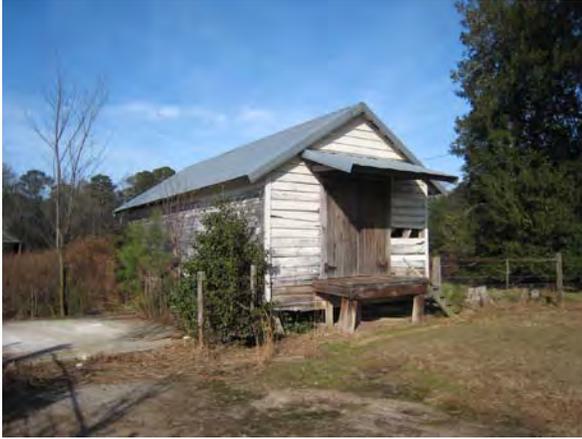
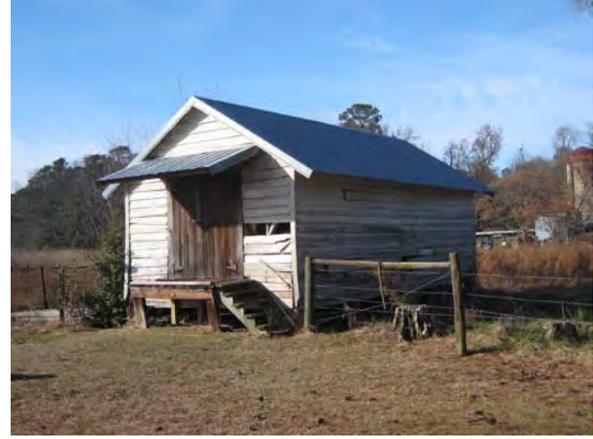
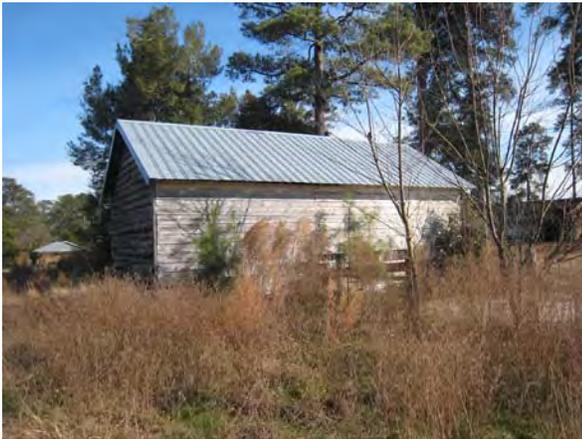
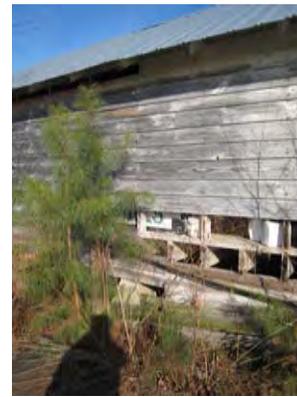
21. FERTILIZER HOUSE

Foundation System: brick and sprayed concrete piers
Condition: fair
Notes: slab on grade adjacent to building approx. 10'x20'

Structural System: 2x4 wood frame walls and trusses
Condition: fair
Notes: wall and roof at 36" O.C., floor is 2x10 at 15" O.C.

Cladding System: horizontal wood lap board
Condition: poor
Notes: many pieces missing or rotten

FCAP Recommendation: replace front entry steps; re-attach or replace siding and doors; replace and seal metal roof where necessary; scrape, sand, clean, and repaint siding

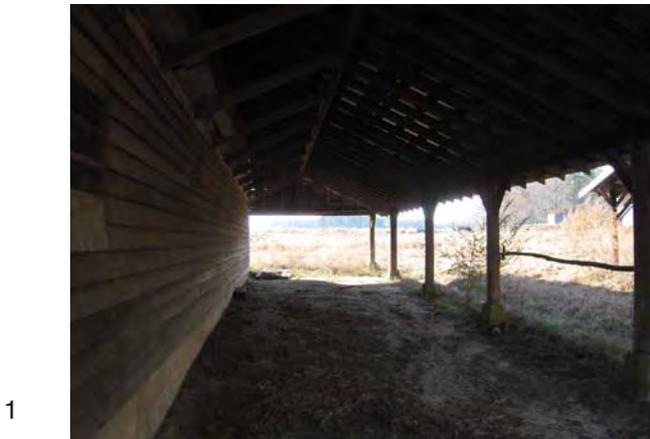
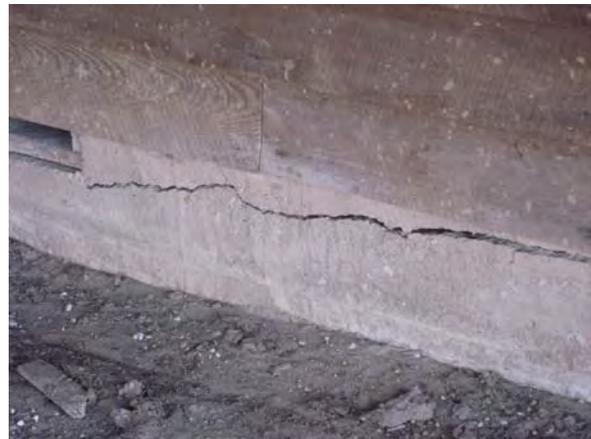
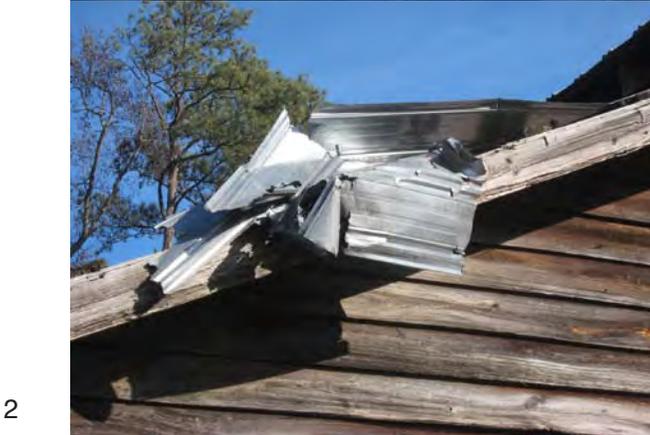
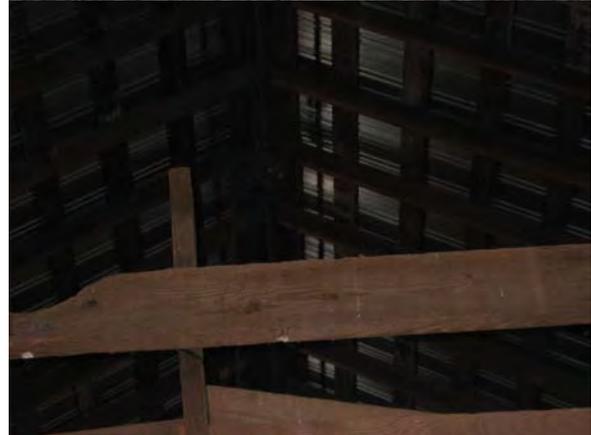
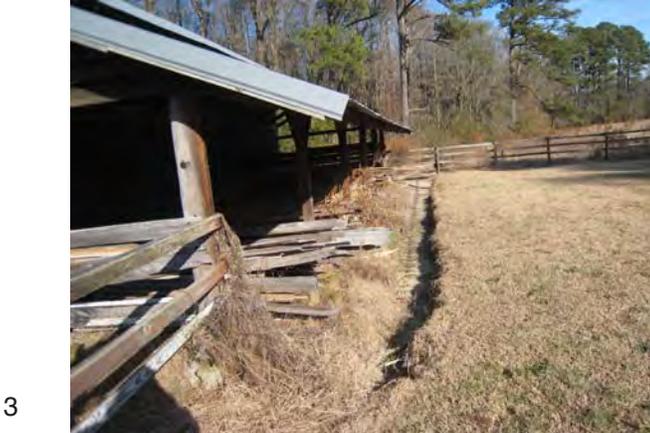
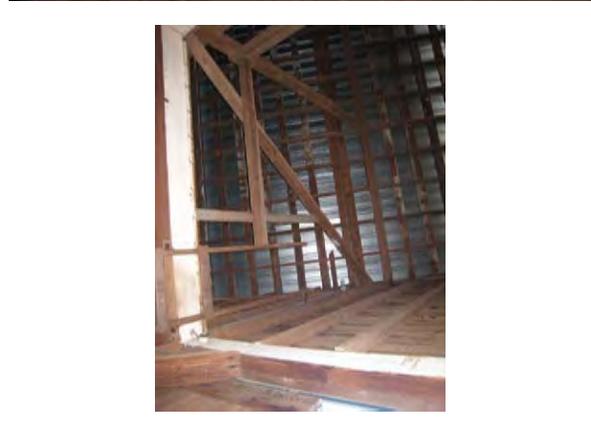
1. shed covering
2. metal roof damage
3. fence and shed
4. foundation cracks
5. inside, roof
6. underside of roof

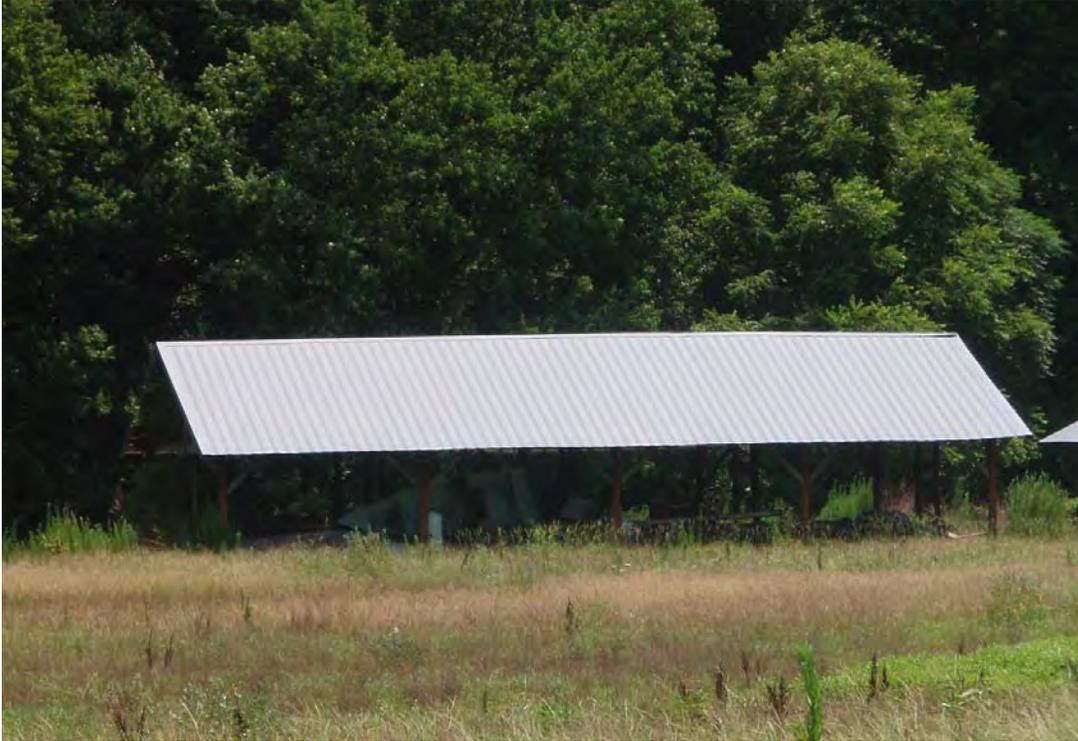
27. FEEDER SHED

Foundation System: concrete slab
Condition: fair, some cracks, structurally good
Notes:

Structural System: poles
Condition: fair, structurally good
Notes: one pole has come unattached but doesn't appear to effect stability at this date
